Title: Heavy-ion induced single event effects and latent damages in SiC power MOSFETs

Heavy-ion induced single event effects and latent damages in SiC power MOSFETs[☆]

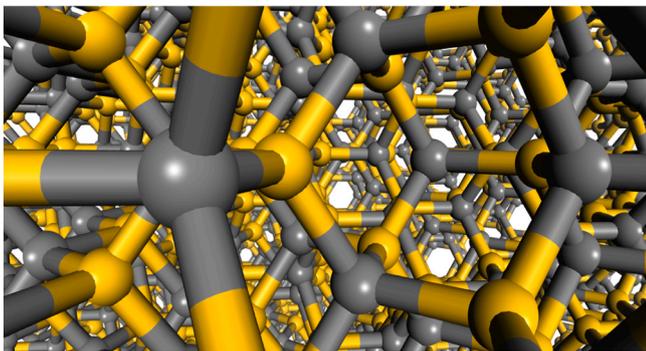
Fig. 1. Three-dimensional perspective of a 4H-SiC crystal in a ball-stick model. Yellow and gray circles represent respectively carbon (C) and silicon (Si) atoms. (For interpretation of the references to color in this figure legend, the reader is referred to the web version of this article.)

The wide-bandgap silicon carbide (SiC) semiconductor has emerged as the most viable alternative to silicon (Si) for the next-generation material for high-efficiency and high-power density applications [1,2]. Compared to Si, SiC exhibits an order of magnitude higher critical field for breakdown, three times larger bandgap, and three times higher thermal conductivity, resulting in about three times more efficient cooling capability [1]. The higher critical field allows manufacturing SiC power devices with much thinner drift layer compared to Si devices, reducing the resistance per unit area, and therefore reducing the conduction losses. Due to the wide bandgap, the intrinsic carrier density at room temperature (i.e., the electrons and holes generated by thermal excitation), is extremely low, enabling the SiC electronic devices to operate at high temperatures with low leakage current. These properties make SiC an attractive material to manufacture power devices by far exceeding the performance limits of their Si counterparts. A three-dimensional representation of the 4H-SiC polytype used to

manufacture power devices is shown in Fig. 1.

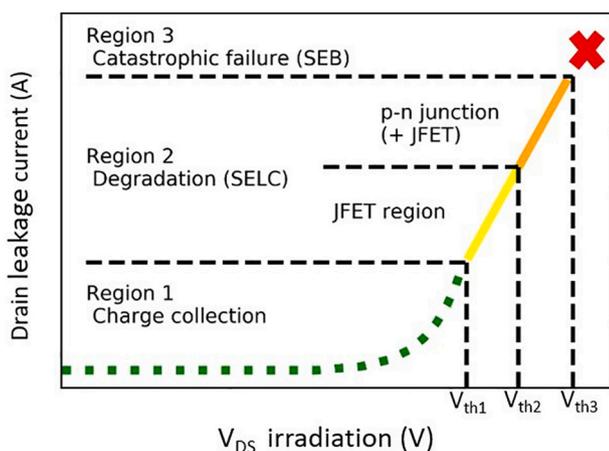
Fig. 2. Conceptual definition of three regions of response of a SiC MOSFET exposed to heavy-ions, represented with the drain-leakage current as a function of the drain-source bias during the irradiation.

Three regions of response are observed when monitoring the drain leakage current (I_D) of SiC power MOSFETs exposed to heavy-ions (a

planar-gate is considered). The three regions are represented in Fig. 2 as a function of the drain-source bias (V_{DS}). At low voltage, the ionization caused by the impinging particle induces only enhanced charge collection, with no permanent damage in the device (Region 1). Increasing the bias, degradation occurs, recently named Single Event Leakage Current (SEL) [10] (Region 2). This effect is characterized by a permanent increase in drain and gate leakage currents with increasing heavy ion fluence. Even though the SEL is non-destructive, the device operation is altered, and it complicates the assessment of radiation reliability for the tested parts. Two sub-regions were identified for this effect, as described in [10,11]. Initially, at a sufficiently high V_{DS} above V_{th1} , the drain and gate leakage currents increase with the same magnitude during the exposure, having a linear proportionality to the fluence. The conductive path is observed between the gate and drain terminals. The induced damage is permanent, and the leakage currents do not recover to the pristine values after the irradiation. From the ion microbeam studies, it was observed that the area underneath the gate (JFET and channel regions) is the most sensitive for this type of damage [10]. For V_{DS} higher than V_{th2} , the second mechanism of degradation becomes active; the gate current (I_G) keeps increasing linearly with respect to the fluence, whereas the drain current (I_D) starts increasing with a much larger magnitude respect to I_G . From the microbeam studies, the p-n junction was identified as the sensitive region at these voltage levels. This second mechanism of degradation was suggested to be the same as observed in SiC diodes, and to be caused by Joule heating, which results in increasing temperature and phase change in the SiC substrate, as confirmed by molecular dynamics simulations [23,24]. These affected regions are unlikely to recover completely, leaving permanent structural modification in SiC lattice, causing the creation of permanent extended defects (ED), such as different dislocations, amorphous pockets, stacking faults, different SiC solid-phase (polytype) inclusions, clusters, and so on [10]. Finally, at V_{DS} higher than V_{th3} , a destructive SEB occurs (Region 3).

The threshold voltages shown in Fig. 2, can vary with the manufacturer and the ion linear energy transfer (LET); a summary for the studied devices is presented in Section 4. In this case, the transition between the two types of degradation was always observed at $V_{th2} \geq 350$ V for LET > 10 MeV cm²/mg, as reported in [11].

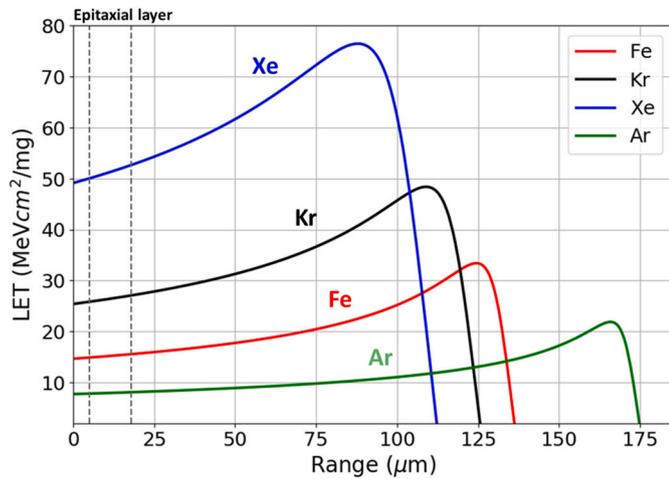
Fig. 3. LETs as a function of the penetration range for the 16.3 MeV/amu heavy-ion species used during the experiments. The dashed lines highlight the thickness of the epitaxial layer of the device.

(Finland). Two experiments were carried out in order to study the latent damage in the gate oxide and in the SiC crystal lattice. Ion broad beams from the 18 GHz Electron Cyclotron Resonance (ECR) ion source, HIISI [26], were used to irradiate commercial SiC MOSFETs. In both cases the irradiations were performed using the 16.3 MeV/amu heavy-ion cocktail, with ⁴⁰Ar⁺¹⁴, ⁵⁶Fe⁺¹⁵, ⁸²Kr⁺²² and ¹³¹Xe⁺³⁵ as the ion species selected for the test. The whole die was homogeneously exposed. The beam characteristics are reported in Table 1. The LET as a function of the penetration range for the four ion species is graphically represented in Fig. 3, where the thickness of the epitaxial layer of the devices is highlighted.

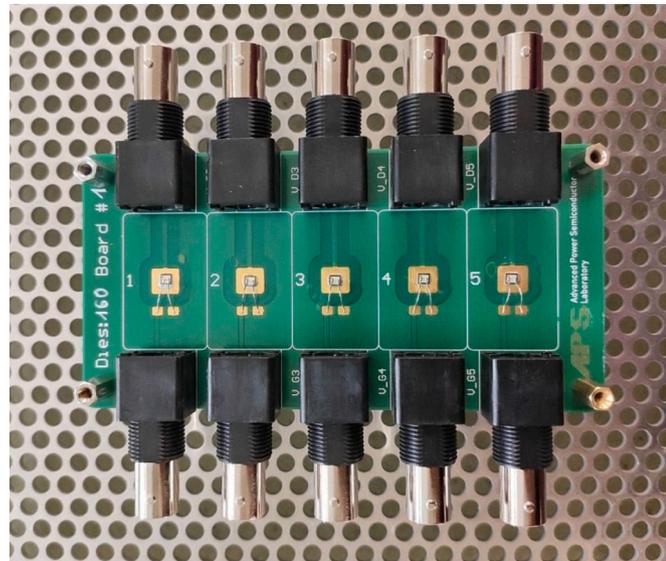
Fig. 4. Experimental board used in RADEF. Each board hosted five die, which were irradiated individually under vacuum. In the picture the die are from the 2nd generation Cree/Wolfspeed, rated for 1.2 kV and with $R_{DS(ON)} = 160$ mΩ. The BNC connectors allow to bias drain and gate and monitor the leakage currents (I_G and I_D).

Bare die from the 2nd generation of Cree/Wolfspeed, rated for $V_{DS} = 1.2$ kV were selected as devices under test (DUTs). Using bare die, the chip surface was directly exposed to the beam, allowing sufficient penetration of the heavy ions through the sensitive active layers of the device, without being stopped in the package materials [27]. The characteristics of the DUTs are listed in Table 2. The gate and source were connected by aluminum wire bonds with 300 μm wire diameter, while the drain connection was made by the soldered bottom pad. The source terminal was directly grounded on the board. Only two wires (gate and source) were used to minimize the shadowing effect. Each board hosted five die, which were irradiated individually in vacuum conditions. Two Keithley Source Measure Units (SMUs), models 2636 and 2410, were used to bias gate and drain through BNC connectors and monitor the gate and drain currents (I_G and I_D), respectively. A picture of the experimental board is shown in Fig. 4.

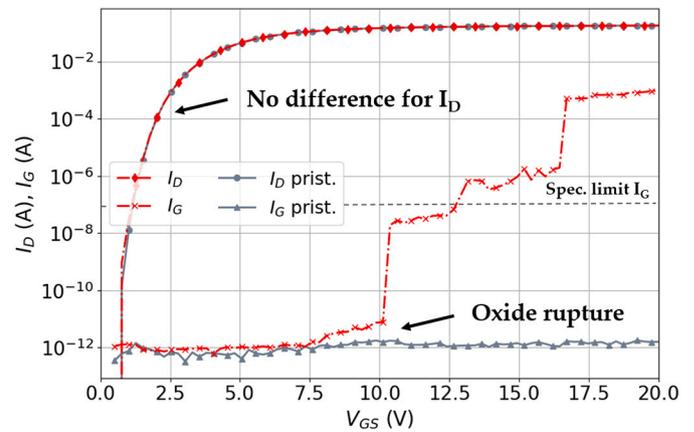
Fig. 5. $I_D V_{GS}$ and $I_G V_{GS}$ of a DUT exposed to ¹³¹Xe⁺³⁵ at $V_{DS} = 60$ V. No degradation was observed during exposure, but oxide breakdown occurred due to the latent damage during the PIGS test at $V_{GS} = 10$ V.

For each ion species, a range for the V_{DS} threshold was identified for the oxide latent damage, as reported in Table 3. The V_{DS} threshold is defined as the minimum bias at which no degradation is observed during the exposure, but the latent damage at the gate is sufficient to cause the oxide rupture during the PIGS test (i.e., $V_{GS} = [0 \text{ V} - 20 \text{ V}]$). For comparison, also the threshold voltages for degradation are reported. The latter were measured either during the current experiment, or during previous experiments with devices from the same generation [10,11]. The results from the run with $^{131}\text{Xe}^{+35}$ at $V_{DS} = 60 \text{ V}$ (and V_{GS} grounded) are shown as an example in Fig. 5. No degradation was observed during the exposure with a fluence up to $10^6 \text{ ions}/\text{cm}^2$, however the gate oxide failed at $V_{GS} = +10 \text{ V}$ during the PIGS test, showing a gate latent damage induced by the ion-exposure. From the application point of view, the device is considered not operable anymore, as $I_G > 100 \text{ nA}$, and therefore out of specifications.

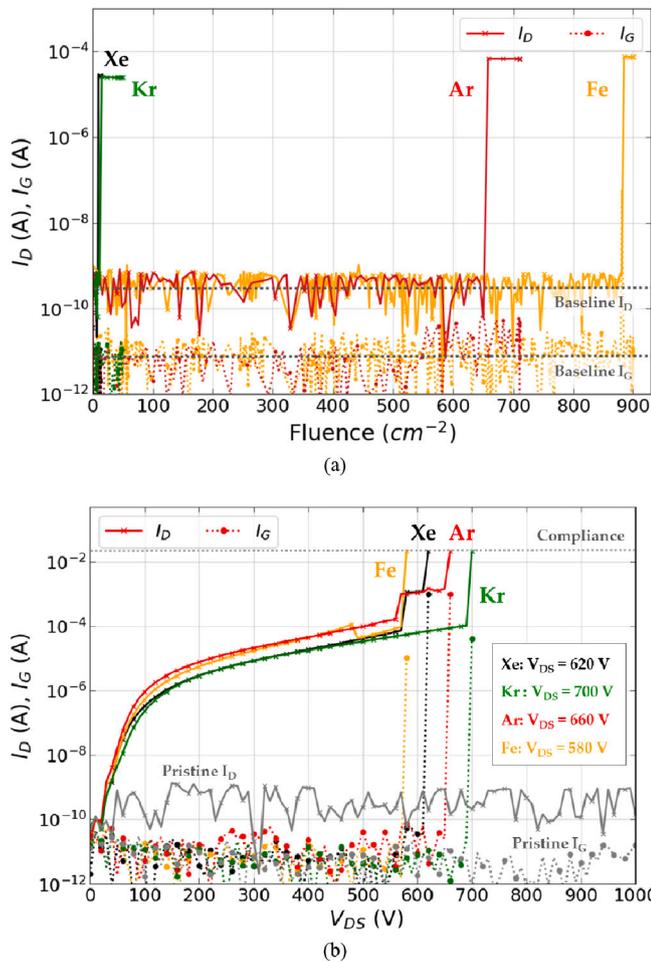
Fig. 6. Results from irradiations with $^{40}\text{Ar}^{+14}$, $^{56}\text{Fe}^{+15}$, $^{82}\text{Kr}^{+22}$ and $^{131}\text{Xe}^{+35}$ ions. a) First degradation step during the exposure at $V_{DS} = 450$ V. b) Post-irradiation V_{DS} sweep; all the devices failed at $580 \text{ V} < V_{DS} < 700$ V. The pristine I_D and I_G are shown in gray.

investigating the latent damage in the SiC crystal lattice in the pre-SEB region. Bare die with $R_{DS(ON)} = 40 \text{ m}\Omega$ (CPM2-1200-0040B) were irradiated at $V_{DS} = 450 \text{ V}$ in order to protect from SEB (for these parts approximately at $V_{DS} = 500 \text{ V}$ with $LET > 10 \text{ MeV cm}^2/\text{mg}$ [13]) and $V_{GS} = 0 \text{ V}$. A flux of few tens of ions/($\text{cm}^2 \text{ s}$) was used, and each die was exposed until the first radiation-induced step was observed. At this bias condition, the devices are experiencing the second type of degradation, which involves the p-n junction and the creation of EDs. The first degradation step was observed only in the I_D , which reached tens of μA , whereas the I_G remained in the order of magnitude of the pristine values. The I_D and I_G results are reported in Table 4 for four DUTs irradiated with $^{40}\text{Ar}^{+14}$, $^{56}\text{Fe}^{+15}$, $^{82}\text{Kr}^{+22}$ and $^{131}\text{Xe}^{+35}$. The same results are graphically represented in Fig. 6(a) as a function of the fluence during the exposure. The pristine values are reported for comparison in the same image (in gray). After the exposure, I_D and I_G were measured simultaneously using the same setup, having $V_{DS} = [0 \text{ V} - 1000 \text{ V}]$ and $V_{GS} = 0 \text{ V}$. As visible in Fig. 6(b), all four DUTs exposed at $V_{DS} = 450 \text{ V}$ failed during the post-irradiation V_{DS} sweep at voltage range of $580 \text{ V} < V_{DS} < 700 \text{ V}$. The failure was defined as $I_D = 20 \text{ mA}$, which is the level of the compliance. As visible in Table 4, in this case the failure

voltage does not show a clear trend with the ion LET. This is probably caused by the different ion-strike position in the unit cell of the MOSFET.

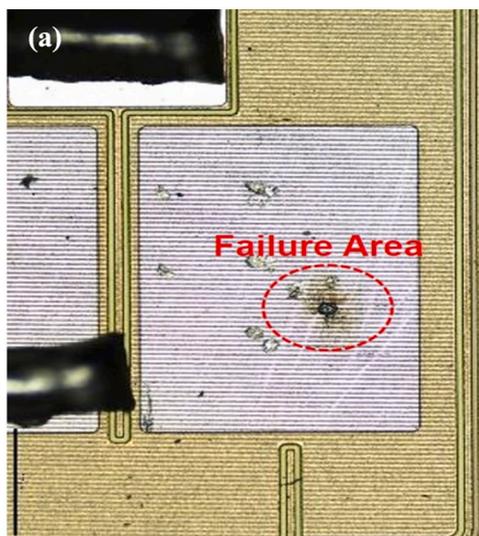
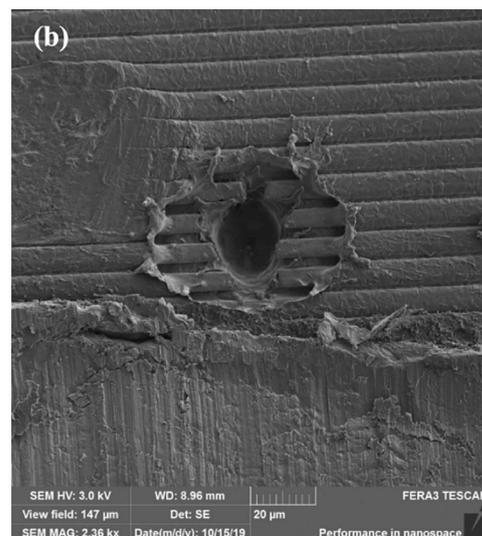
Fig. 7. Images of the failure are on the die surface obtained with (a) microscope and (b) SEM analysis measured with SE detector.

The damage site caused by the post-irradiation V_{DS} measurement was investigated using a plasma FIB-SEM analysis. The device analyzed was tested on a previous experiment performed with a microbeam as described in [10] but showed the same type of post-irradiation damage. The device was exposed to Ca ion ($LET = 17 \text{ MeV cm}^2/\text{mg}$) with an accumulated fluence of $6 \times 10^3 \text{ ions/cm}^2$. Initially, the failure area was identified using a microscope, as visible in Fig. 7(a). Fig. 7(b) shows a SEM image of the damage site on the die surface measured with SE detector. The hole generated by the failure extends over more than three gate stripes, for a length of $\sim 30 \mu\text{m}$ and a width of $\sim 20 \mu\text{m}$. Fig. 8(a) and Fig. 8(b) show the cross-section of the hole after FIB milling, measured with SE and BSE detector, respectively. The hole has a depth of $\sim 18 \mu\text{m}$, and it extends over the entire epilayer (which has a depth from $5 \mu\text{m}$ to $18 \mu\text{m}$). The image shows that the SiC crystal has decomposed, meaning that the localized temperature in the failure region reached the

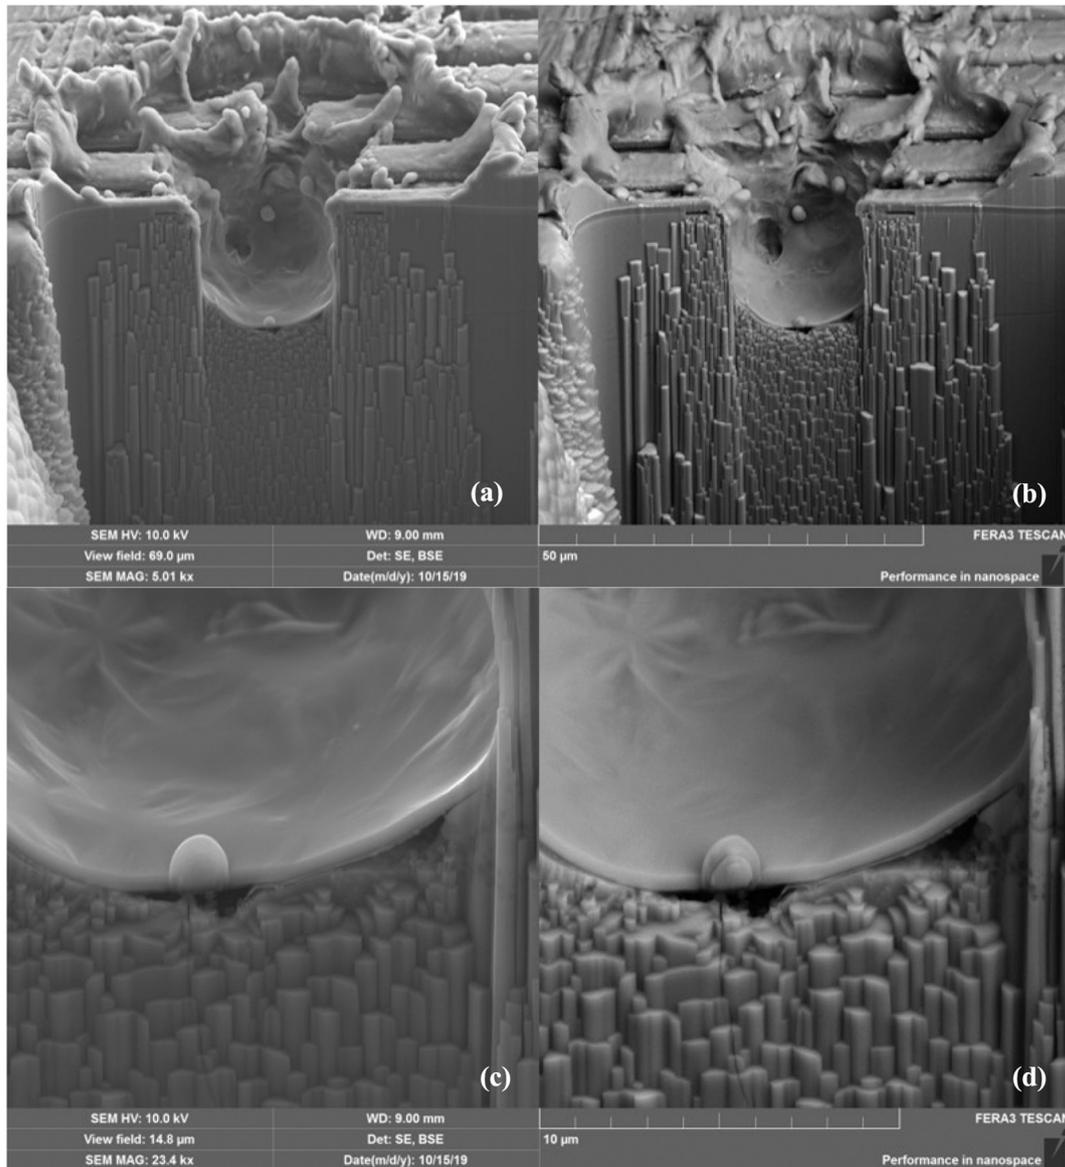
Fig. 8. In the top row: cross-section of the damaged area after FIB milling, measured with (a) SE and (b) BSE detectors. In the bottom row: magnified view of the hole showed in the previous images, measured with (c) SE and (d) BSE detectors.

decomposition temperature of 4H SiC ($3103\text{ K} \pm 35\text{ atm}$ [28]), and the materials in the layers above, which have a lower melting point, filled the hole. Fig. 8(c) and Fig. 8(d) are magnified views of the hole showed in the previous images, measured with SE and BSE detector, respectively. A crack which starts at the bottom of the hole is visible in both images. Finally, the vertical columns that appear in the cross-sections are artifacts due to the preparation of the sample.

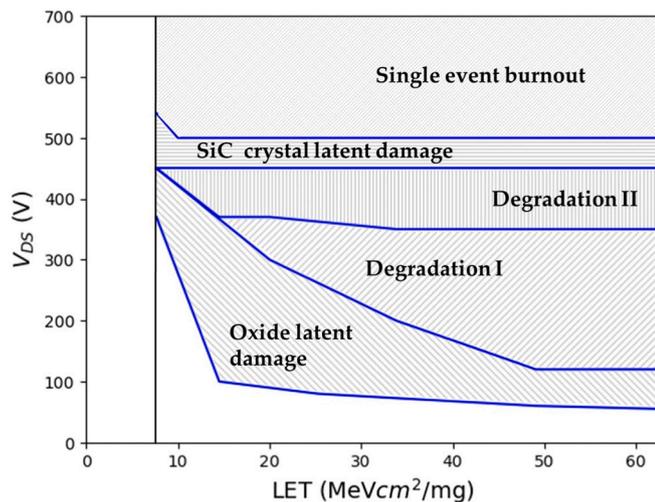
Fig. 9. Overview of the different types of damage induced by heavy-ion in SiC power MOSFETs as a function of the ion LET. The data were collected testing planar-gate MOSFETs from the 2nd generation Cree/Wolfspeed. The plot follows the representation as proposed in [10] for SiC diodes.

The heavy-ion-induced effects in the 2nd generation SiC MOSFET devices from Cree/Wolfspeed are graphically represented in Fig. 9 as a function of the ion LET and the V_{DS} during the exposure. The plot follows the representation as proposed in [17] for SiC diodes. The data were collected in the current work and previous ones [10,11] for devices irradiated in off-state. Five different regions of damage with the respective thresholds are identified.

A “hockey stick” trend is observed for all the effects, with the regions becoming narrower and the threshold voltages less distinguishable with decreasing LET. No data was collected for $\text{LET} < 7.7\text{ MeV cm}^2/\text{mg}$, but eventually the ion damage is insufficient to induce degradation and latent damage, and the device directly experience SEB at higher bias.

At low drain-source bias, the first type of effect observed is the gate latent damage discussed in Section 3.1. The V_{DS} necessary to observe this effect is extremely low compared to the maximum rated voltage (less than a tenth). The threshold for this effect was identified for a fluence of 10^6 ion/cm^2 . At higher bias, the heavy-ion exposure induces the first type of SELC, named “degradation I” in this graph, where the area underneath the gate oxide is the most sensitive (JFET region + channels). Increasing the voltage, the second type of SELC, labelled “degradation II”, is observed. In this case the damage involves mostly the p-n junction region, but a smaller leakage remains also through the gate-oxide. This type of degradation involves damage in the SiC lattice and generation of EDs. The transition between the two types of degradation might vary between device generations and manufacturers, as recently reported in literature [5]. Furthermore, over a certain V_{DS} threshold in the pre-SEB region ($V_{DS} \geq 450\text{ V}$ in this case), a second latent damage involves the SiC crystal lattice which is altered by the presence of EDs. After the irradiation, when drain-source bias is applied, the localized power density induces an increase of local temperature, which ultimately causes the decomposition of the SiC crystal and the creation of a crater, as described in Sections 3.2 and 3.3. Finally, for

higher voltages, the device experiences directly a destructive SEB, as reported in [13] for $V_{DS} > 500\text{ V}$ and $\text{LETs} > 10\text{ MeV cm}^2/\text{mg}$.

This graph can be used as a qualitative baseline also for other devices with a planar gate. However, since in this work all the heavy-ions experiments were performed using planar MOSFETs from Cree/Wolfspeed and considering that design and carrier concentrations vary between device types and manufacturers, the results cannot be transferred to all SiC power devices without further analysis.
