Title: Heavy-ion induced single event effects and latent damages in SiC power MOSFETs

Heavy-ion induced single event effects and latent damages in SiC power MOSFETs[☆]

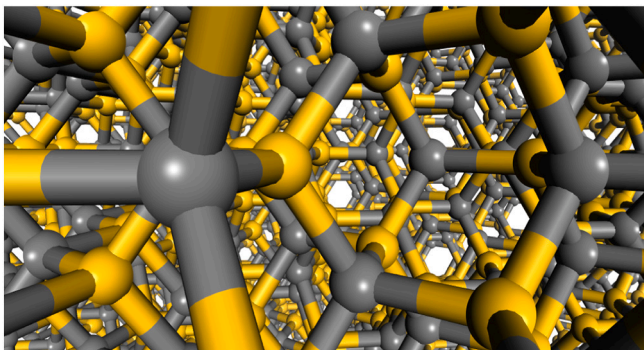
Fig. 1. Three-dimensional perspective of a 4H-SiC crystal in a ball-stick model. Yellow and gray circles represent respectively carbon (C) and silicon (Si) atoms. (For interpretation of the references to color in this figure legend, the reader is referred to the web version of this article.)

The wide-bandgap silicon carbide (SiC) semiconductor has emerged as the most viable alternative to silicon (Si) for the next-generation material for high-efficiency and high-power density applications [1,2]. Compared to Si, SiC exhibits an order of magnitude higher critical field for breakdown, three times larger bandgap, and three times higher thermal conductivity, resulting in about three times more efficient cooling capability [1]. The higher critical field allows manufacturing SiC power devices with much thinner drift layer compared to Si devices, reducing the resistance per unit area, and therefore reducing the conduction losses. Due to the wide bandgap, the intrinsic carrier density at room temperature (i.e., the electrons and holes generated by thermal excitation), is extremely low, enabling the SiC electronic devices to operate at high temperatures with low leakage current. These properties make SiC an attractive material to manufacture power devices by far exceeding the performance limits of their Si counterparts. A three-dimensional representation of the 4H-SiC polytype used to

manufacture power devices is shown in Fig. 1.

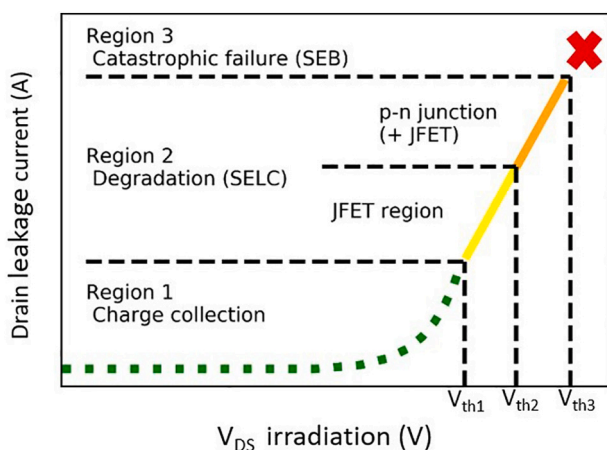
Fig. 2. Conceptual definition of three regions of response of a SiC MOSFET exposed to heavy-ions, represented with the drain-leakage current as a function of the drain-source bias during the irradiation.

planar-gate is considered). The three regions are represented in Fig. 2 as a function of the drain-source bias (V_{DS}). At low voltage, the ionization caused by the impinging particle induces only enhanced charge collection, with no permanent damage in the device (Region 1). Increasing the bias, degradation occurs, recently named Single Event Leakage Current (SEL) [10] (Region 2). This effect is characterized by a permanent increase in drain and gate leakage currents with increasing heavy ion fluence. Even though the SEL is non-destructive, the device operation is altered, and it complicates the assessment of radiation reliability for the tested parts. Two sub-regions were identified for this effect, as described in [10,11]. Initially, at a sufficiently high V_{DS} above V_{th1} , the drain and gate leakage currents increase with the same magnitude during the exposure, having a linear proportionality to the fluence. The conductive path is observed between the gate and drain terminals. The induced damage is permanent, and the leakage currents do not recover to the pristine values after the irradiation. From the ion microbeam studies, it was observed that the area underneath the gate (JFET and channel regions) is the most sensitive for this type of damage [10]. For V_{DS} higher than V_{th2} , the second mechanism of degradation becomes active; the gate current (I_G) keeps increasing linearly with respect to the fluence, whereas the drain current (I_D) starts increasing with a much larger magnitude respect to I_G . From the microbeam studies, the p-n junction was identified as the sensitive region at these voltage levels. This second mechanism of degradation was suggested to be the same as observed in SiC diodes, and to be caused by Joule heating, which results in increasing temperature and phase change in the SiC substrate, as confirmed by molecular dynamics simulations [23,24]. These affected regions are unlikely to recover completely, leaving permanent structural modification in SiC lattice, causing the creation of permanent extended defects (ED), such as different dislocations, amorphous pockets, stacking faults, different SiC solid-phase (polytype) inclusions, clusters, and so on [10]. Finally, at V_{DS} higher than V_{th3} , a destructive SEB occurs (Region 3).

The threshold voltages shown in Fig. 2, can vary with the manufacturer and the ion linear energy transfer (LET); a summary for the studied devices is presented in Section 4. In this case, the transition between the two types of degradation was always observed at $V_{th2} \geq 350$ V for $LET > 10$ MeV cm²/mg, as reported in [11].

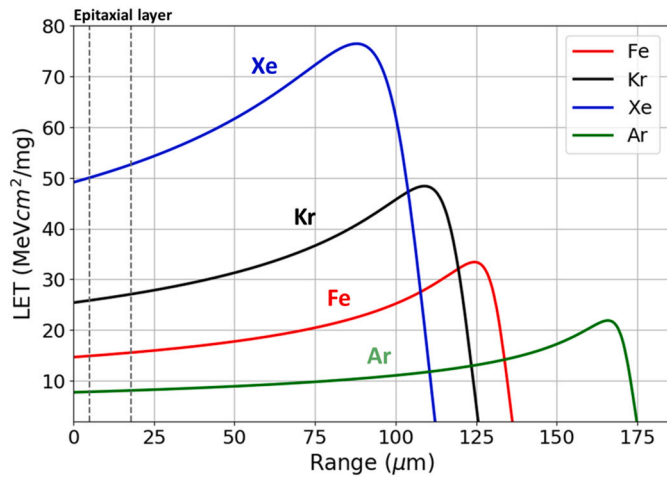
Fig. 3. LETs as a function of the penetration range for the 16.3 MeV/amu heavy-ion species used during the experiments. The dashed lines highlight the thickness of the epitaxial layer of the device.

(Finland). Two experiments were carried out in order to study the latent damage in the gate oxide and in the SiC crystal lattice. Ion broad beams from the 18 GHz Electron Cyclotron Resonance (ECR) ion source, HIISI [26], were used to irradiate commercial SiC MOSFETs. In both cases the irradiations were performed using the 16.3 MeV/amu heavy-ion cocktail, with ⁴⁰Ar⁺¹⁴, ⁵⁶Fe⁺¹⁵, ⁸²Kr⁺²² and ¹³¹Xe⁺³⁵ as the ion species selected for the test. The whole die was homogeneously exposed. The beam characteristics are reported in Table 1. The LET as a function of the penetration range for the four ion species is graphically represented in Fig. 3, where the thickness of the epitaxial layer of the devices is highlighted.

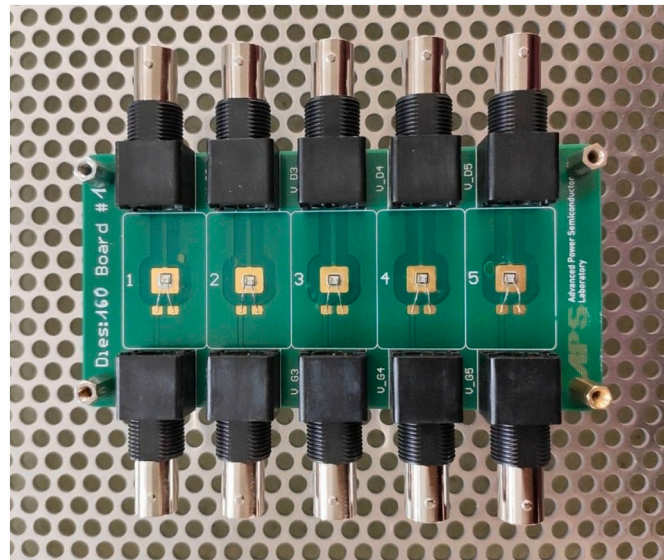
Fig. 4. Experimental board used in RADEF. Each board hosted five die, which were irradiated individually under vacuum. In the picture the die are from the 2nd generation Cree/Wolfspeed, rated for 1.2 kV and with $R_{DS(ON)} = 160$ mΩ. The BNC connectors allow to bias drain and gate and monitor the leakage currents (I_G and I_D).

Bare die from the 2nd generation of Cree/Wolfspeed, rated for $V_{DS} = 1.2$ kV were selected as devices under test (DUTs). Using bare die, the chip surface was directly exposed to the beam, allowing sufficient penetration of the heavy ions through the sensitive active layers of the device, without being stopped in the package materials [27]. The characteristics of the DUTs are listed in Table 2. The gate and source were connected by aluminum wire bonds with 300 μm wire diameter, while the drain connection was made by the soldered bottom pad. The source terminal was directly grounded on the board. Only two wires (gate and source) were used to minimize the shadowing effect. Each board hosted five die, which were irradiated individually in vacuum conditions. Two Keithley Source Measure Units (SMUs), models 2636 and 2410, were used to bias gate and drain through BNC connectors and monitor the gate and drain currents (I_G and I_D), respectively. A picture of the experimental board is shown in Fig. 4.

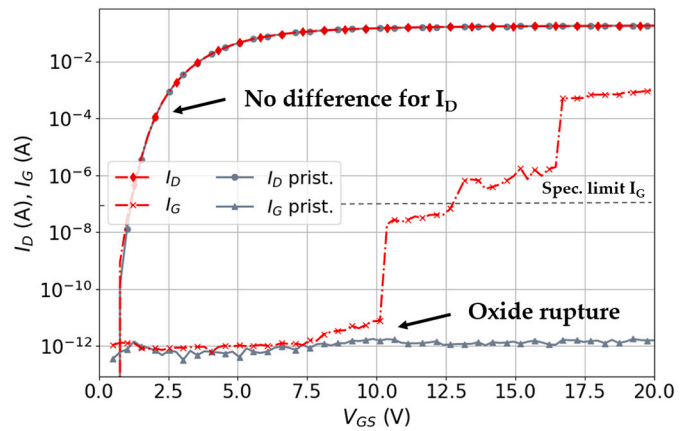
Fig. 5. $I_D V_{GS}$ and $I_G V_{GS}$ of a DUT exposed to ¹³¹Xe⁺³⁵ at $V_{DS} = 60$ V. No degradation was observed during exposure, but oxide breakdown occurred due to the latent damage during the PIGS test at $V_{GS} = 10$ V.

For each ion species, a range for the V_{DS} threshold was identified for the oxide latent damage, as reported in Table 3. The V_{DS} threshold is defined as the minimum bias at which no degradation is observed during the exposure, but the latent damage at the gate is sufficient to cause the oxide rupture during the PIGS test (i.e., $V_{GS} = [0 \text{ V} - 20 \text{ V}]$). For comparison, also the threshold voltages for degradation are reported. The latter were measured either during the current experiment, or during previous experiments with devices from the same generation [10,11]. The results from the run with $^{131}\text{Xe}^{+35}$ at $V_{DS} = 60 \text{ V}$ (and V_{GS} grounded) are shown as an example in Fig. 5. No degradation was observed during the exposure with a fluence up to $10^6 \text{ ions}/\text{cm}^2$, however the gate oxide failed at $V_{GS} = +10 \text{ V}$ during the PIGS test, showing a gate latent damage induced by the ion-exposure. From the application point of view, the device is considered not operable anymore, as $I_G > 100 \text{ nA}$, and therefore out of specifications.

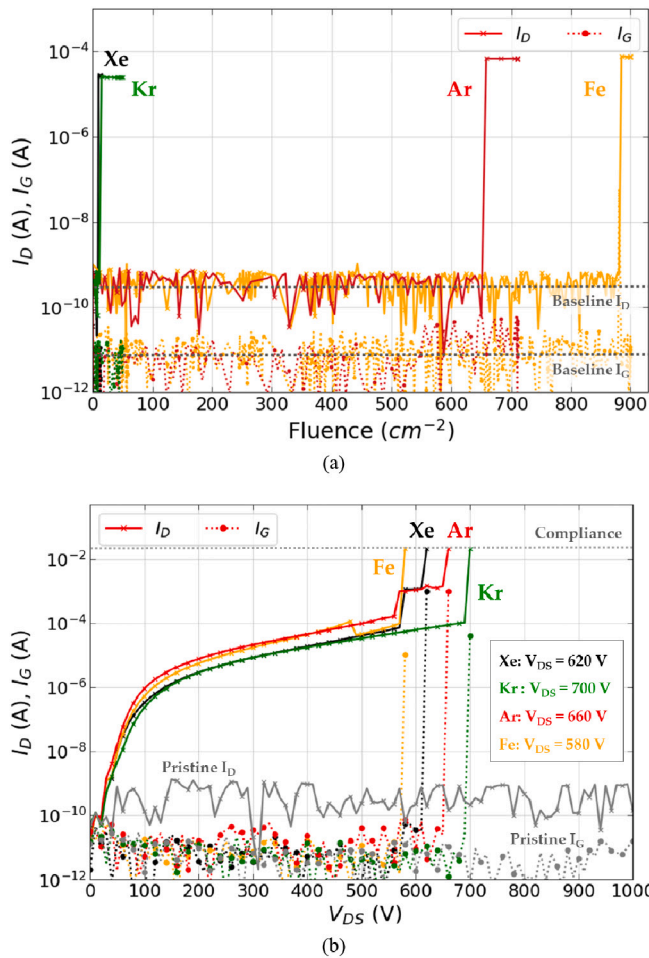
Fig. 6. Results from irradiations with $^{40}\text{Ar}^{+14}$, $^{56}\text{Fe}^{+15}$, $^{82}\text{Kr}^{+22}$ and $^{131}\text{Xe}^{+35}$ ions. a) First degradation step during the exposure at $V_{DS} = 450$ V. b) Post-irradiation V_{DS} sweep; all the devices failed at $580 \text{ V} < V_{DS} < 700$ V. The pristine I_D and I_G are shown in gray.

investigating the latent damage in the SiC crystal lattice in the pre-SEB region. Bare die with $R_{DS(ON)} = 40 \text{ m}\Omega$ (CPM2-1200-0040B) were irradiated at $V_{DS} = 450 \text{ V}$ in order to protect from SEB (for these parts approximately at $V_{DS} = 500 \text{ V}$ with $LET > 10 \text{ MeV cm}^2/\text{mg}$ [13]) and $V_{GS} = 0 \text{ V}$. A flux of few tens of ions/($\text{cm}^2 \text{ s}$) was used, and each die was exposed until the first radiation-induced step was observed. At this bias condition, the devices are experiencing the second type of degradation, which involves the p-n junction and the creation of EDs. The first degradation step was observed only in the I_D , which reached tens of μA , whereas the I_G remained in the order of magnitude of the pristine values. The I_D and I_G results are reported in Table 4 for four DUTs irradiated with $^{40}\text{Ar}^{+14}$, $^{56}\text{Fe}^{+15}$, $^{82}\text{Kr}^{+22}$ and $^{131}\text{Xe}^{+35}$. The same results are graphically represented in Fig. 6(a) as a function of the fluence during the exposure. The pristine values are reported for comparison in the same image (in gray). After the exposure, I_D and I_G were measured simultaneously using the same setup, having $V_{DS} = [0 \text{ V} - 1000 \text{ V}]$ and $V_{GS} = 0 \text{ V}$. As visible in Fig. 6(b), all four DUTs exposed at $V_{DS} = 450 \text{ V}$ failed during the post-irradiation V_{DS} sweep at voltage range of $580 \text{ V} < V_{DS} < 700 \text{ V}$. The failure was defined as $I_D = 20 \text{ mA}$, which is the level of the compliance. As visible in Table 4, in this case the failure

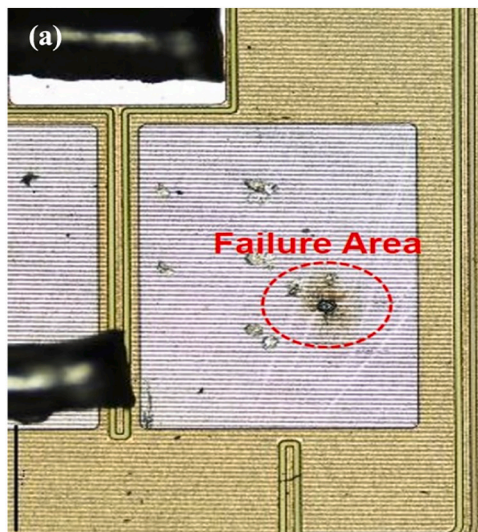
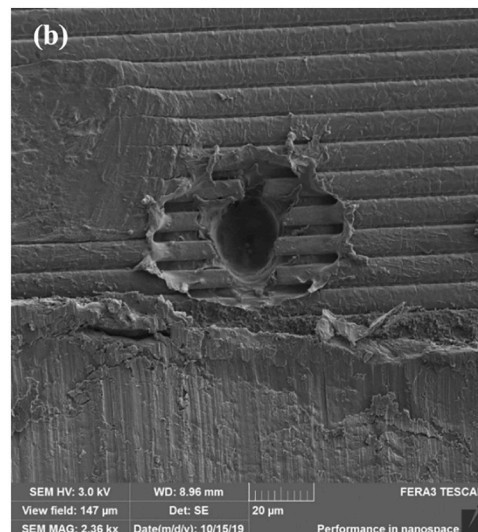
Fig. 7. Images of the failure are on the die surface obtained with (a) microscope and (b) SEM analysis measured with SE detector.

The damage site caused by the post-irradiation V_{DS} measurement was investigated using a plasma FIB-SEM analysis. The device analyzed was tested on a previous experiment performed with a microbeam as described in [10] but showed the same type of post-irradiation damage. The device was exposed to Ca ion ($LET = 17 \text{ MeV cm}^2/\text{mg}$) with an accumulated fluence of $6 \times 10^3 \text{ ions/cm}^2$. Initially, the failure area was identified using a microscope, as visible in Fig. 7(a). Fig. 7(b) shows a SEM image of the damage site on the die surface measured with SE detector. The hole generated by the failure extends over more than three gate stripes, for a length of $\sim 30 \mu\text{m}$ and a width of $\sim 20 \mu\text{m}$. Fig. 8(a) and Fig. 8(b) show the cross-section of the hole after FIB milling, measured with SE and BSE detector, respectively. The hole has a depth of $\sim 18 \mu\text{m}$, and it extends over the entire epilayer (which has a depth from $5 \mu\text{m}$ to $18 \mu\text{m}$). The image shows that the SiC crystal has decomposed, meaning that the localized temperature in the failure region reached the

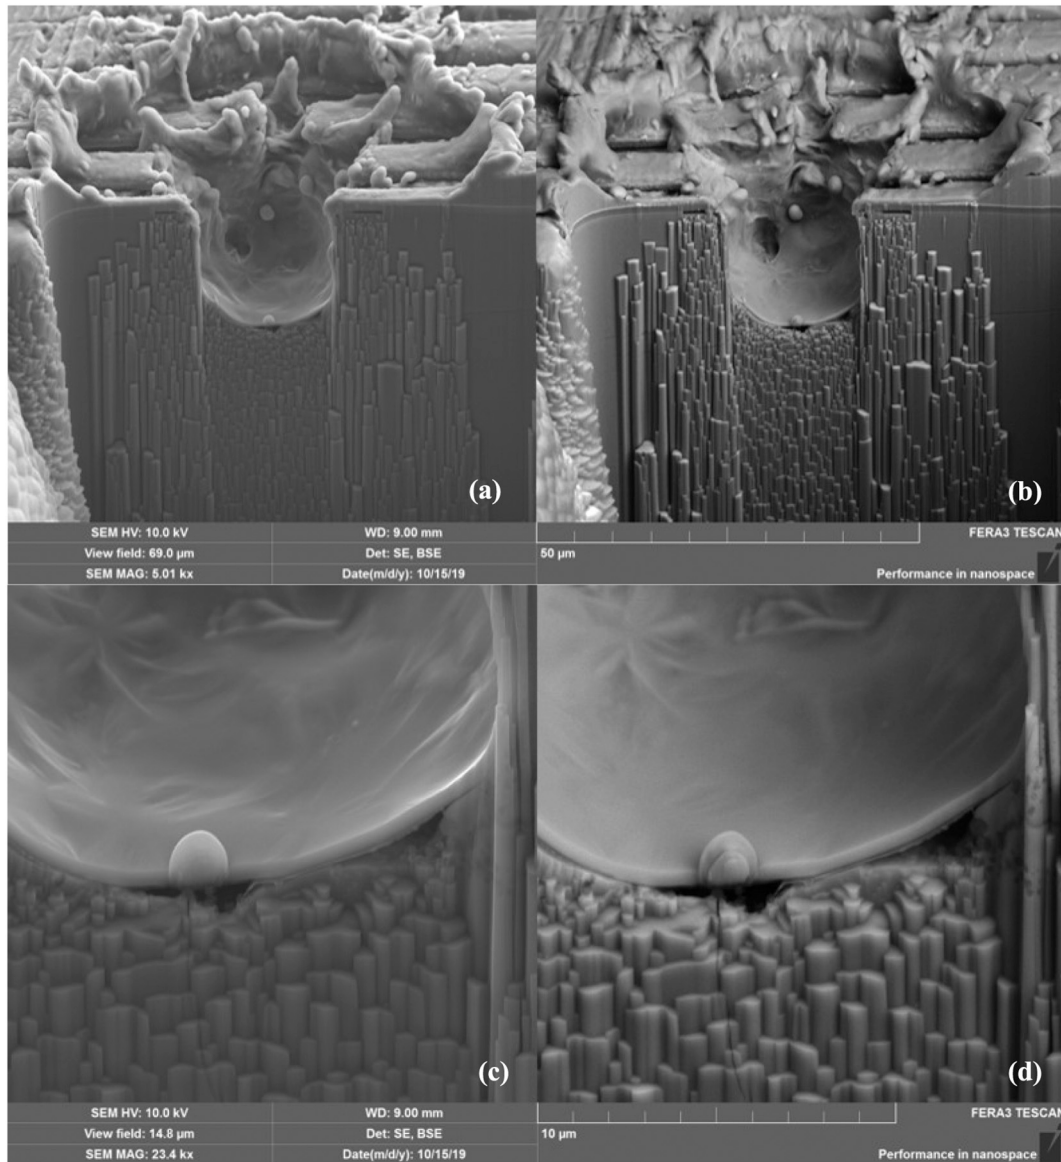
Fig. 8. In the top row: cross-section of the damaged area after FIB milling, measured with (a) SE and (b) BSE detectors. In the bottom row: magnified view of the hole showed in the previous images, measured with (c) SE and (d) BSE detectors.

decomposition temperature of 4H SiC ($3103\text{ K} \pm 35\text{ atm}$ [28]), and the materials in the layers above, which have a lower melting point, filled the hole. Fig. 8(c) and Fig. 8(d) are magnified views of the hole showed in the previous images, measured with SE and BSE detector, respectively. A crack which starts at the bottom of the hole is visible in both images. Finally, the vertical columns that appear in the cross-sections are artifacts due to the preparation of the sample.

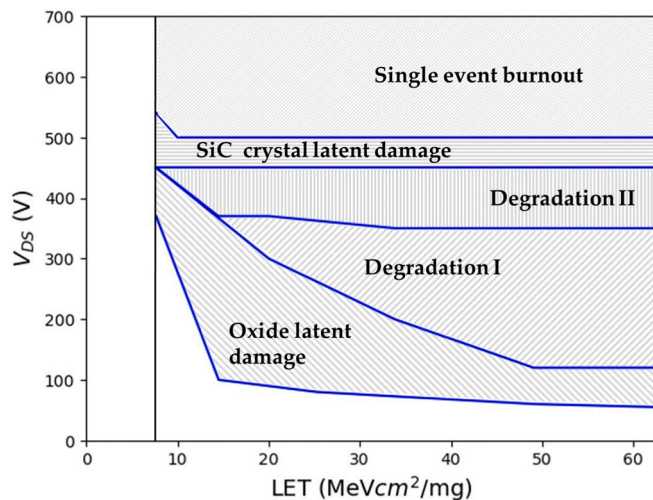
Fig. 9. Overview of the different types of damage induced by heavy-ion in SiC power MOSFETs as a function of the ion LET. The data were collected testing planar-gate MOSFETs from the 2nd generation Cree/Wolfspeed. The plot follows the representation as proposed in [10] for SiC diodes.

The heavy-ion-induced effects in the 2nd generation SiC MOSFET devices from Cree/Wolfspeed are graphically represented in Fig. 9 as a function of the ion LET and the V_{DS} during the exposure. The plot follows the representation as proposed in [17] for SiC diodes. The data were collected in the current work and previous ones [10,11] for devices irradiated in off-state. Five different regions of damage with the respective thresholds are identified.

A “hockey stick” trend is observed for all the effects, with the regions becoming narrower and the threshold voltages less distinguishable with decreasing LET. No data was collected for $LET < 7.7\text{ MeV cm}^2/\text{mg}$, but eventually the ion damage is insufficient to induce degradation and latent damage, and the device directly experience SEB at higher bias.

At low drain-source bias, the first type of effect observed is the gate latent damage discussed in Section 3.1. The V_{DS} necessary to observe this effect is extremely low compared to the maximum rated voltage (less than a tenth). The threshold for this effect was identified for a fluence of 10^6 ion/cm^2 . At higher bias, the heavy-ion exposure induces the first type of SELC, named “degradation I” in this graph, where the area underneath the gate oxide is the most sensitive (JFET region + channels). Increasing the voltage, the second type of SELC, labelled “degradation II”, is observed. In this case the damage involves mostly the p-n junction region, but a smaller leakage remains also through the gate-oxide. This type of degradation involves damage in the SiC lattice and generation of EDs. The transition between the two types of degradation might vary between device generations and manufacturers, as recently reported in literature [5]. Furthermore, over a certain V_{DS} threshold in the pre-SEB region ($V_{DS} \geq 450\text{ V}$ in this case), a second latent damage involves the SiC crystal lattice which is altered by the presence of EDs. After the irradiation, when drain-source bias is applied, the localized power density induces an increase of local temperature, which ultimately causes the decomposition of the SiC crystal and the creation of a crater, as described in Sections 3.2 and 3.3. Finally, for
