Title: Effect of Hot Dip Galvanized Steel Surface Chemistry and Morphology on Titanium Hexafluoride Pretreatment

Saarimaa, V., Markkula, A., Arstila, K., Manni, J., & Juhanoja, J. (2017). Effect of Hot Dip Galvanized Steel Surface Chemistry and Morphology on Titanium Hexafluoride Pretreatment. *Advances in Materials Physics and Chemistry*, 7(2), 28-41.
<https://doi.org/10.4236/ampc.2017.72004>

Effect of Hot Dip Galvanized Steel Surface Chemistry and Morphology on Titanium Hexafluoride Pretreatment

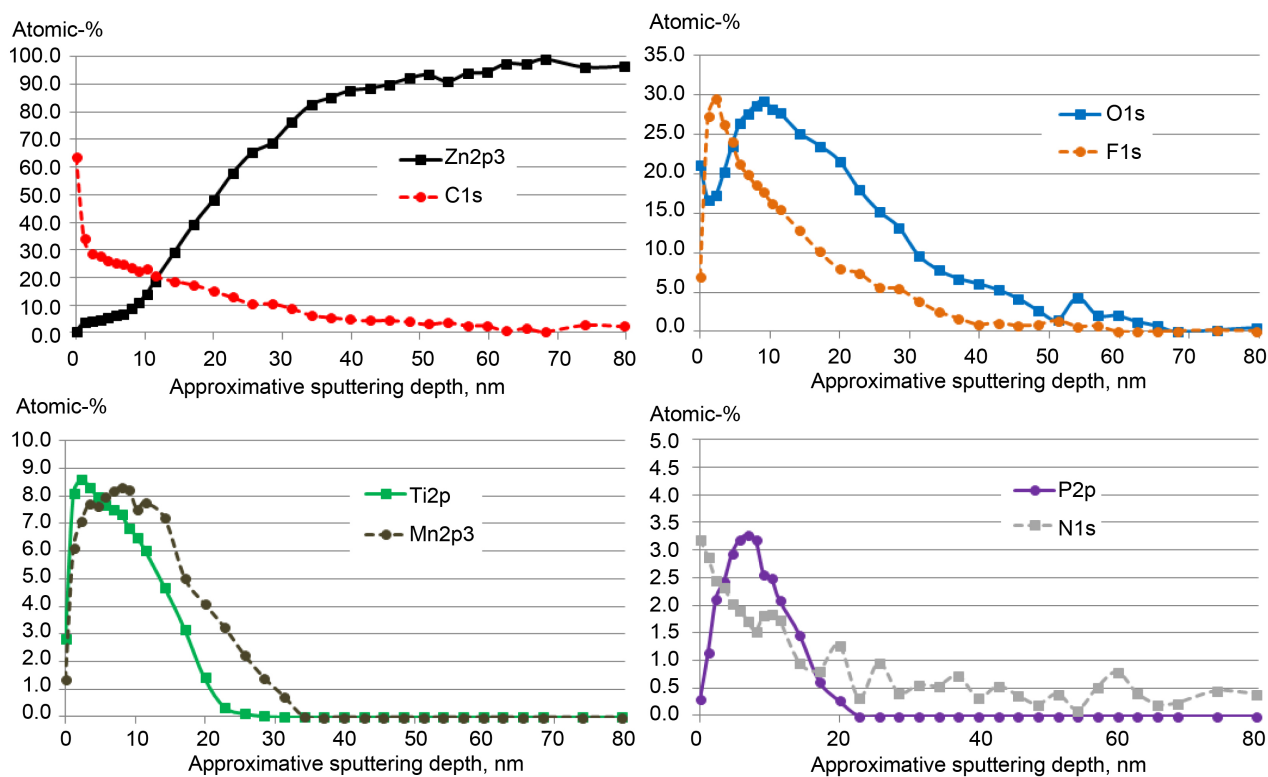
Figure 4. XPS depth profiles of the different elements in the pretreated layer on a non temper rolled hot dip galvanized steel sample (concentration of the cleaning chemical was 4.0 g/L). The results are averages of three parallel measurements. Al was not detected.

Samples with low removal of aluminum (0.2 g/L) and high removal of aluminum (4.0 g/L) were pretreated. XPS depth profiles of the different elements within the pretreatment layers are shown in **Figure 3** and **Figure 4**. Over 60 atomic-% of the outermost surface was composed of carbon in both samples. The carbon signal decreased rapidly after mild sputtering, which confirmed that the carbon on the surface was present as a surface impurity. The true carbon signal,

The approximative thickness of the pretreatment layer was significantly higher in the well cleaned sample (**Figure 4**) than in the sample with mild cleaning (**Figure 3**). Also, aluminum was detected only in the latter sample. Since the pretreatment step was identical for the both samples, it can be deduced that the sample with mild cleaning was less reactive than the well cleaned sample. Stellnberger *et al.* [25] showed by electrochemical quartz crystal microbalance measurements that the reactivity of a galvanized steel sample increases with alkaline cleaning. Similar results have been obtained in other pretreatment and coating studies [6] [7] [26]. The investigations are underway to establish a critical level of surface aluminum oxide removal for good coating adhesion.
