**Master's thesis**

**Success of stream channel restoration in the Iijoki  
catchment area**

**Eevi Kocis**

**University of Jyväskylä**

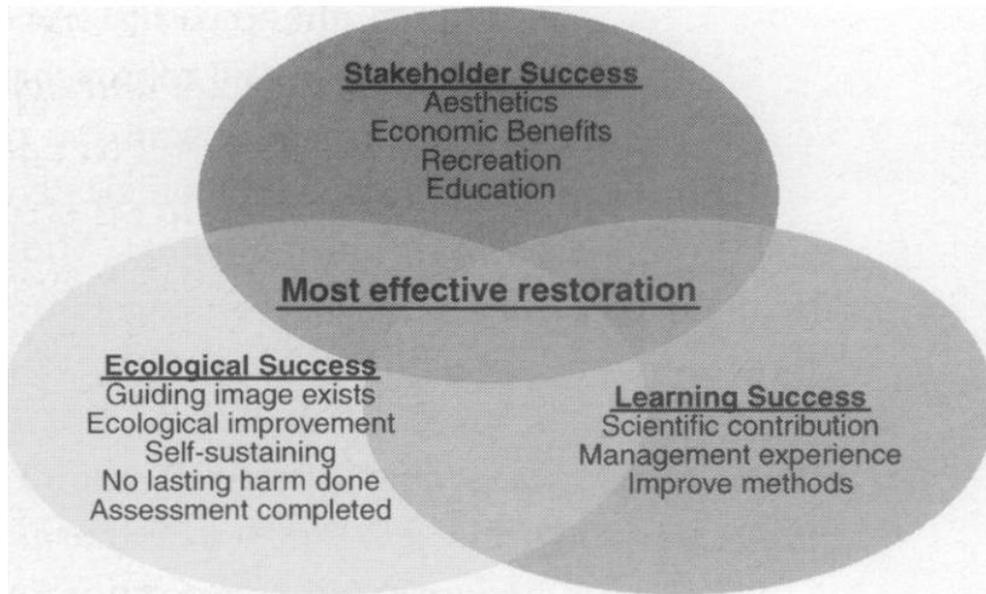
Figure 1. Three primary restoration success aspects that create the most effective restoration (Palmer et al. 2005).

According to Palmer et al. (2005) ecologically successful restoration includes a dynamic guiding image of hydrology, geomorphology, physical habitat, biology and the probability of the fact that these system variables are not static. Guiding image should consider how much local restoration can then contribute to the restoration in the watershed-level. Restoration should improve the ecosystems (for example improve water quality, increase the ecosystem functions and/or return natural flow regime) and increase their resilience towards future disturbances. Pre- and post-monitoring of the restoration project should show that the impacts of restoration activities did not cause irreversible damage to the ecosystem. In addition, ecological assessment of the project has to be completed. This assessment includes setting clear project goals with evidence that the post-restoration data were collected from the variables of interest and that the results were analyzed and distributed to all interested parties. Most effective river restoration success considers ecological success, stakeholder success which reflects to human satisfaction with the restoration (for example aesthetics, economic benefits and recreation) and learning success which will benefit future restoration action (for example management experience and improvement in the methods) (Palmer et al. 2005) (Figure 1).
