Single-Event Effects in the Peripheral Circuitry of a Commercial Ferroelectric Random-Access Memory

Abstract – This study identifies the failure modes of a commercial 130 nm ferroelectric random-access memory (FRAM). The devices were irradiated with heavy-ion and pulsed focused X-ray beams. Various failure modes are observed, which generate characteristic error patterns, affecting isolated bits, words, groups of pages, and sometimes entire regions of the memory array. The underlying mechanisms are discussed.

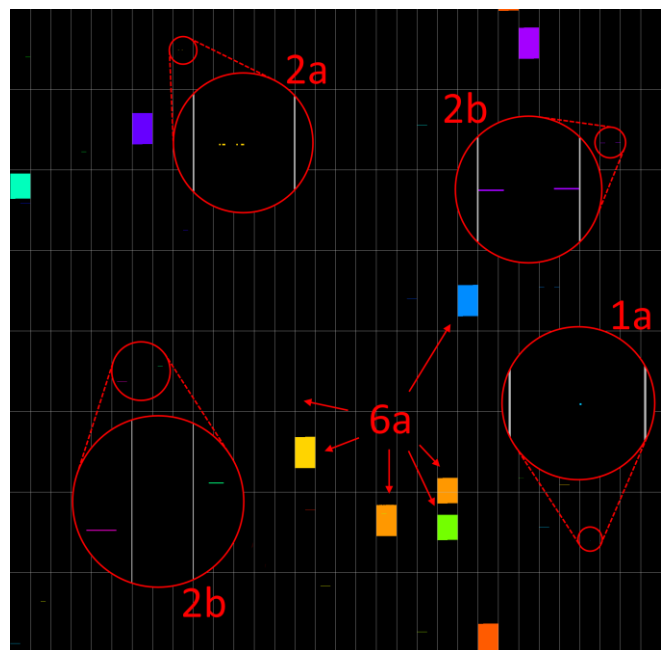
-Type 1 (Figure 1): 1-bit failures. These events can be isolated (type 1a), but sometimes several 1-bit failures can occur at different times at *related* addresses (sharing many bits) or within the same page (type 1b). Type 1 events were observed on all test campaigns, during both static and dynamic tests.

-Type 2 (Figure 1): several bits in one word are upset at once. The word is either partially corrupted (type 2a) or completely corrupted (type 2b). Type 2 events were observed on all test campaigns, during both static and dynamic tests.

Figure 1: Logical/chronological bitmap obtained from an mMats+ test with xenon (LET 64.3 MeV.cm².mg⁻¹) on DUT #1, exhibiting SEE types 1a, 2a, 2b and 6a.

Figures 1 and 2 exhibit logical/chronological bitmaps from the results of two dynamic heavy-ion irradiation tests, on which different failure types can be observed. They can be classified into several categories, which have been numbered by increasing order of importance:

-Type 6 (Figures 1, 2 and 7): several hundred consecutively-accessed words are either completely upset (type 6a), or completely upset except for a few occasional bits (type 6b). The colored blocks appearing on Figures 1 and 2 are type 6a events. The number of words affected by type 6 failures seems to be directly influenced by the type of dynamic test, and more precisely, by the speed at which the algorithm scans across the address space. Figure 1 exhibits several type 6a events, each affecting about 350 words. The data for this figure was gathered during an mMats+ test; the elements of this algorithm contain two operations each. The data used for Figure 2 was gathered on the same DUT in exactly similar conditions, except that the test algorithm was Dynamic Classic, whose elements only contain one operation – meaning that the Dynamic Classic algorithm scans addresses faster. Figure 2 also exhibits several type 6a events, but in this case each event affects about 770 words. This correlation between algorithm scanning speed and type 6 event severity was verified on tens of different test runs; it indicates that type 6 events last for a constant amount of time (or a constant amount of I/O operations). Type 6 events were observed only on heavy-ion campaigns, dynamic tests only.

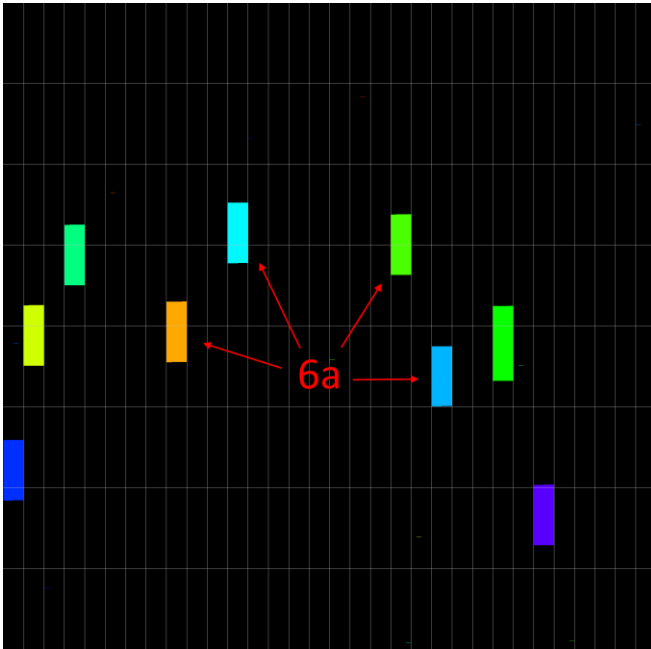
Figure 2: Logical/chronological bitmap obtained from a Dynamic Classic test with xenon (LET 60 MeV.cm².mg⁻¹) on DUT #1, showing SEE type 6a for comparison with Fig.1.

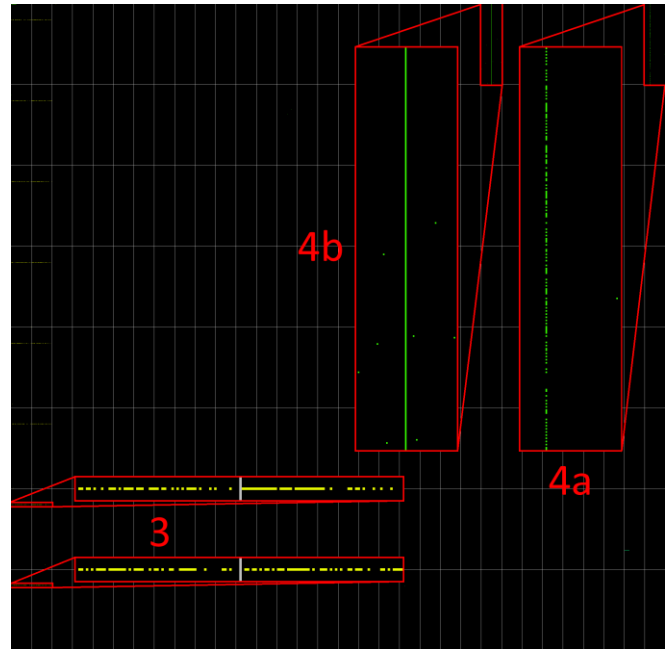
-Type 3 (Figure 3): several pages, which have the same *page number* (appear at the same height within their logical bitmap sectors) exhibit large numbers of upsets affecting several words. Type 3 errors were only observed on heavy-ion campaigns, and only on dynamic tests.

-Type 4 (Figure 3): one particular bit of every page within a logic sector suffers either intermittent errors (type 4a) or continuous errors (type 4b), resulting in an interrupted or continuous vertical line on the logical bitmap, respectively. In addition, sparse single-bit upsets (SBUs) may occur randomly within the affected sector. Type 4 events were observed on all test campaigns, mostly on dynamic tests.

Figure 3: Logical/chronological bitmap obtained from an mMats+ test with nitrogen (LET 1.8 MeV.cm².mg⁻¹) on DUT #3, exhibiting SEE types 3, 4a and 4b.

Horizontal divisions (every 256 lines) and vertical divisions (64 columns/1 page wide) are displayed on the bitmaps to ease their interpretation. Separation lines divide a bitmap in 256 bitmap *sectors*; the height of these sectors matches the height of some error cluster types (e.g. type 4; see Figure 3).

Type 4 SEE: the facts that this type of event occurred during X-ray periphery testing, and that most of the errors generated occur at the same bit of the same word within their page suggest two possible fault mechanisms. The first hypothesis is an upset of a redundancy register, with the consequence of either reallocating a functional column to a spare column (thus not correctly initialized), creating a continuous 4b event; or the re-allocation of a spare column to a malfunctioning column (not supposed to be used), or the allocation of a functioning column to a malfunctioning spare (not supposed to be used), resulting in an intermittent 4a error. The second hypothesis is the occurrence of a micro-latchup event or a stuck bit in a page buffer. Such events induce metastability in the buffer cells, explaining the occurrence of seemingly random errors occurring concurrently to the “vertical lines” in the rest of the page buffer positions during type 4 events (see Figure 3).

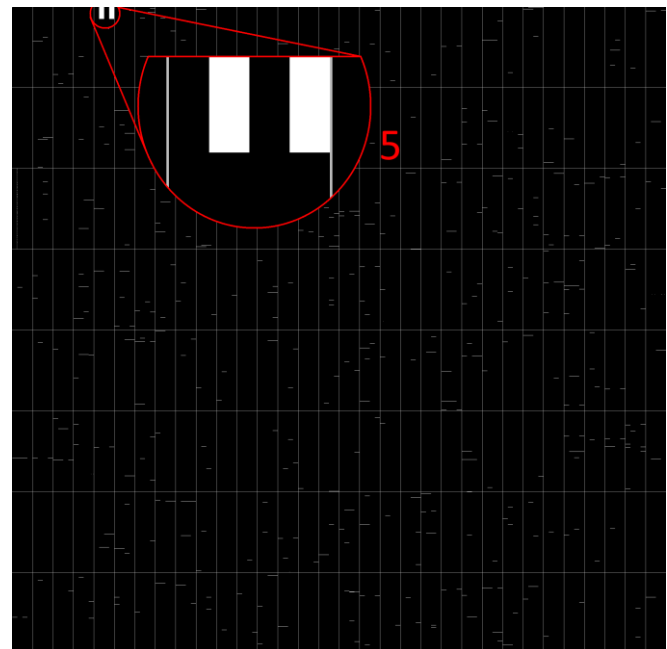
-Type 5: the chronological bitmap on display on Figure 4 was gathered during an anti-Gray Dynamic Stress test on DUT #4. It exhibits, among type 1 and 2 events, two small blocks of errors in the top left corner; each block is made of 37 completely upset words. A closer examination of the data logs reveals that each of these 76 addresses actually returned errors on several occasions, during two consecutive element scans of the Dynamic stress algorithm. During the first element scan, after the w0 operation, the five consecutive r0 operations all failed on each of these addresses; then, on the next element scan, the first operation, r0, failed on all these addresses. Subsequent accesses to these memory locations returned no errors for the rest of the test.

Figure 4: chronological bitmap obtained from a Dynamic Stress test with argon at 30° on DUT #4, with SEE type 5.

The logical bitmap for this test run is available on Figure 5. This figure shows how all the errors visible on the chronological bitmap in Figure 4 have closely related addresses (they are close to each other on the logical bitmap).

radiation, one or more bits from the buffer get stuck, then the requested operation will be performed at the wrong memory location. This hypothesis is supported by the chronological bitmap, which indicates that during the event, in chronological order, every other address accessed failed. This is consistent with the fact that all address bits -but one-toggle from one access to the next in anti-Gray addressing mode: the stuck bit fault can only trigger errors on every other position accessed.

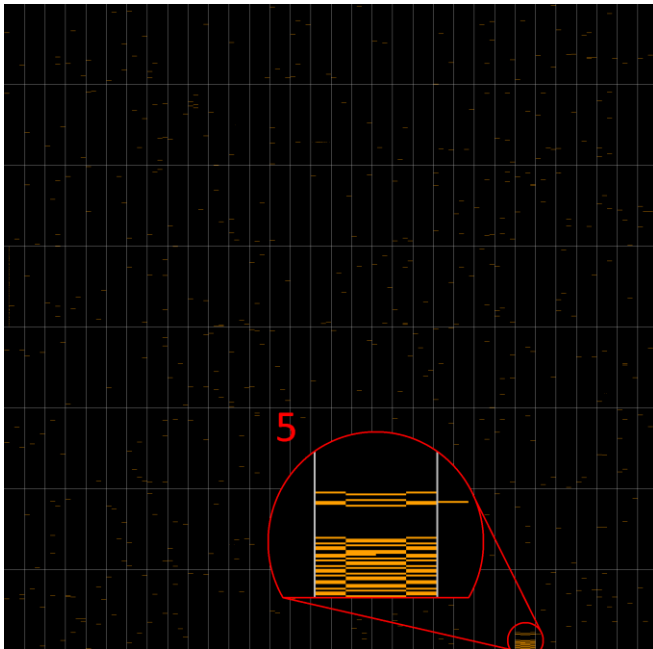
Figure 5: logical bitmap generated from the same data as that used in Figure 4; the zoom-in identifies the errors highlighted in the zoom-in of Figure 4. The complex pattern is caused by the anti-Gray addressing used in this test.

Another explanation for this event could be a failure of the write operation of the first element of the algorithm. As indicated by Figure 5, all the words involved in this event have related addresses, which means that there is a high probability that they share common read/write control circuits. It is possible that locally, the peripheral elements required for write operations were temporarily disabled by an ion strike. This hypothesis is supported by the fact that no other large group of errors is visible on the logical bitmap.

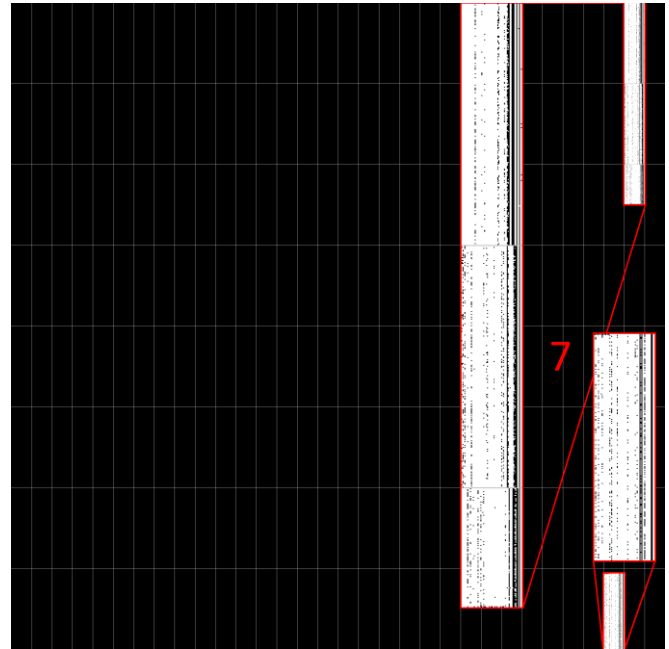
-Type 7 (Figure 6): several thousands to tens of thousands of consecutively-accessed words are affected with a high density of random upsets, generating hundreds of thousands to millions of upsets. The device may eventually recover from the condition spontaneously. The type 7 event visible on Figure 6 is the logical/chronological bitmap from a pulsed X-ray test on DUT #5 at APS. The beam scanned a region of the central peripheral spine, while a natural-order mMats+ dynamic test was performed. This type of SEFI also occurred during heavy-ion dynamic testing.

Figure 6: Logical/chronological bitmap obtained from an mMats+ pulsed X-ray test aimed at the central peripheral spine of DUT #5, exhibiting a type 7 SEE (the two bands visible in the zoom-ins belong to the same event).

Type 7 events are large-scale functional interrupts, which do not affect an “even” amount of words (a power of 2), seemingly start and stop at random address positions, and trigger a pseudorandom output, could originate in an upset of device configuration registers, or in a micro-latch-up affecting peripheral elements. Micro-latch-up conditions have been shown to disappear spontaneously in CMOS devices, when the high voltage lines sustaining them are switched off as part of normal device activity [11].

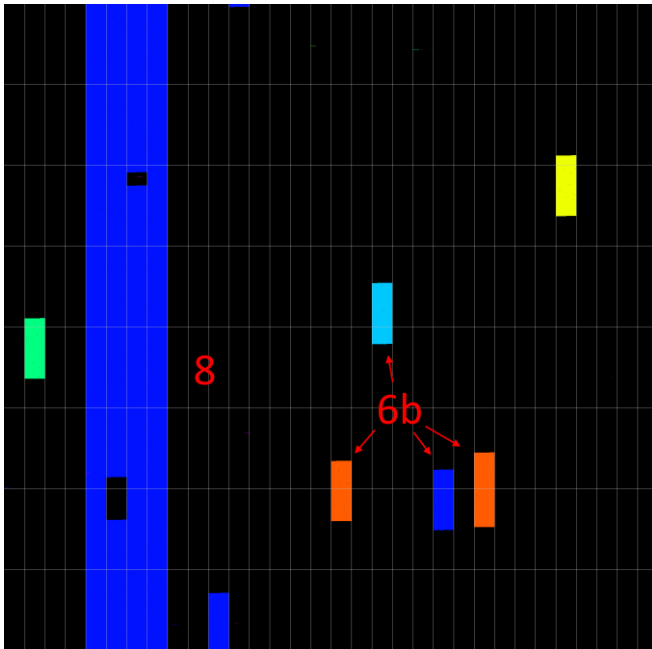
-Type 8 (Figure 7): several thousands to tens of thousands of words are either entirely, or almost entirely corrupted; these words all have a few address bits in common. This is evidenced by the fact that on a logical bitmap, the errors generated by type 8 events fill up entire binary subdivisions of the bitmap – either the whole bitmap, or one half, or one or more quarters or eighths, etc. This is evident on Figure 7, where a type 8 event takes up a whole eighth of the bitmap. Since this is a logical bitmap from a natural-addressing test, it means that the type 8 event started as the third most-significant address bit toggled from 0 to 1, and ended as soon as it toggled back to 0. This type of event was recorded on all heavy-ion test campaigns, but only on dynamic tests. Type 8 events were also detected on dynamic tests where the addressing was not natural – for example, anti-Gray. This means that the errors which appear during a type 8 event are not necessarily accessed consecutively.

Figure 7: logical bitmap from a natural Dynamic Classic test with krypton ($LET\ 32.1\ MeV.cm^2.mg^{-1}$) on DUT #2, exhibiting a type 8 and several type 6b events.

Type 8 events are large-scale failures which affect an “even” amount of words (a power of 2). They begin and end when certain address bits toggle; since each address bit controls one level of address decoding, type 8 events must be “mapped” on the memory array. For example, the type 8 event visible on Figure 7 affected exactly one eighth of the memory array; since the memory array is organized in eight blocks, one possibility is that a radiation-induced upset in a configuration register disabled a critical element in one of the eight memory blocks – and that subsequent accesses to this memory block returned an erroneous value. Since three address bits are used to select blocks, the type 8 event started when the lowest-level block-selecting bit toggled, and ended when another block was selected at the next toggle. Possible origins for these events could be upsets in configuration registers (e.g. controlling power switches feeding memory blocks).
