Title: Heavy-Ion Microbeam Studies of Single-Event Leakage Current Mechanism in SiC VD-MOSFETs

Heavy-Ion Microbeam Studies of Single-Event Leakage Current Mechanism in SiC VD-MOSFETs

Abstract—Heavy-ion microbeams are employed for probing the radiation-sensitive regions in commercial silicon carbide (SiC) vertical double-diffused power (VD)-MOSFETs with micrometer accuracy. By scanning the beam spot over the die, a spatial periodicity was observed in the leakage current degradation, reflecting the striped structure of the power MOSFET investigated. Two different mechanisms were observed for degradation. At low drain bias (gate and source grounded), only the gate-oxide (at the JFET or neck region) is contributing in the ion-induced leakage current. For exposures at drain–source bias voltages higher than a specific threshold, additional higher drain leakage current is observed in the p-n junction region. This provides useful insights into the understanding of basic phenomena of single-event effects in SiC power devices.

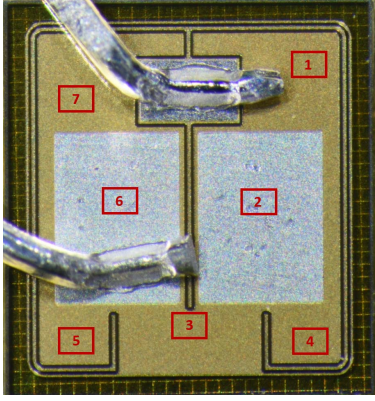
Fig. 1. Regions of the 80-mΩ die irradiated with Au beam (not to scale).

considerations are valid also for the 25- and 65-mΩ DUTs. For an exemplary 80-mΩ DUT, the irradiated regions are indicated in Fig. 1 (not to scale). During Au irradiation, gradual permanent degradation (SELC) in the device was observed at $V_{DS\ irr} > 150$ V ($\sim 12.5\%$ of the rated voltage). At drain biases below 350 V ($\sim 30\%$ of the rated voltage), the magnitude and degradation rate of the leakage currents, for both drain and gate, were equal. Similarly, it was observed for the 25-mΩ devices, while for the 65-mΩ devices from the third generation, equal gate and drain current were observed at $V_{DS\ irr} < 320$ V ($\sim 35\%$ rated voltage).

Different regions of the die were exposed to heavy ions, and detailed analyses were done for the second-generation 80-m Ω devices. The response to heavy ions was observed to be homogenous over the scanned areas around the die (as shown in Fig. 1).

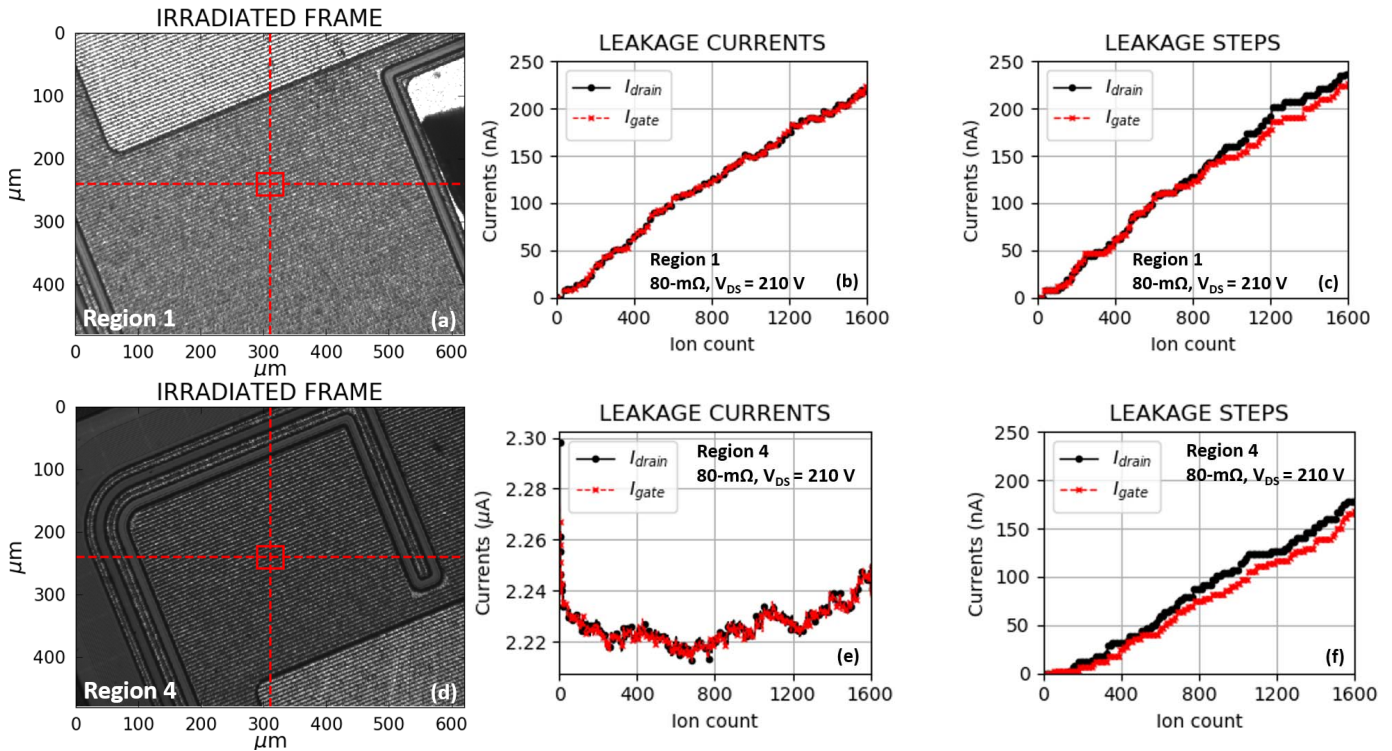
Fig. 2. Au irradiation in regions 1 and 4 of an 80-m Ω at $V_{DS\ irr} = 210$ V. The exact location of the irradiation is identified by the window frame on the microscope images, respectively, in (a) and (d). The drain and gate leakage current increases are shown in (b) and (e) (for a pristine device, the leakage currents are on the order of 10 pA), while in (c) and (f) is the cumulative sum of the radiation-induced leakage steps.

Two examples for an 80-mΩ die exposed to Au beam in regions 1 and 4 at $V_{DS\ irr} = 210$ V are shown in Fig. 2. The corresponding positions of the scanning areas are visible on the micrographs in Fig. 2(a) and (d). The leakage current evolution during the irradiations is shown in Fig. 2(b) and (e). The heavy-ion-induced steps were analyzed from the leakage current evolution by using a threshold step height of 2.5 nA to filter the background noise and are reported in Fig. 2(c) and (f).

had been degraded to a certain level. In the run shown in Fig. 2(b), the device exposed to the beam was pristine, while

in the run shown in Fig. 2(e), the part was already damaged. In the latter case, the leakage current was on the order

of microamperes. Comparing the current evolutions, for the degraded part [Fig. 2(e)], higher current values are measured

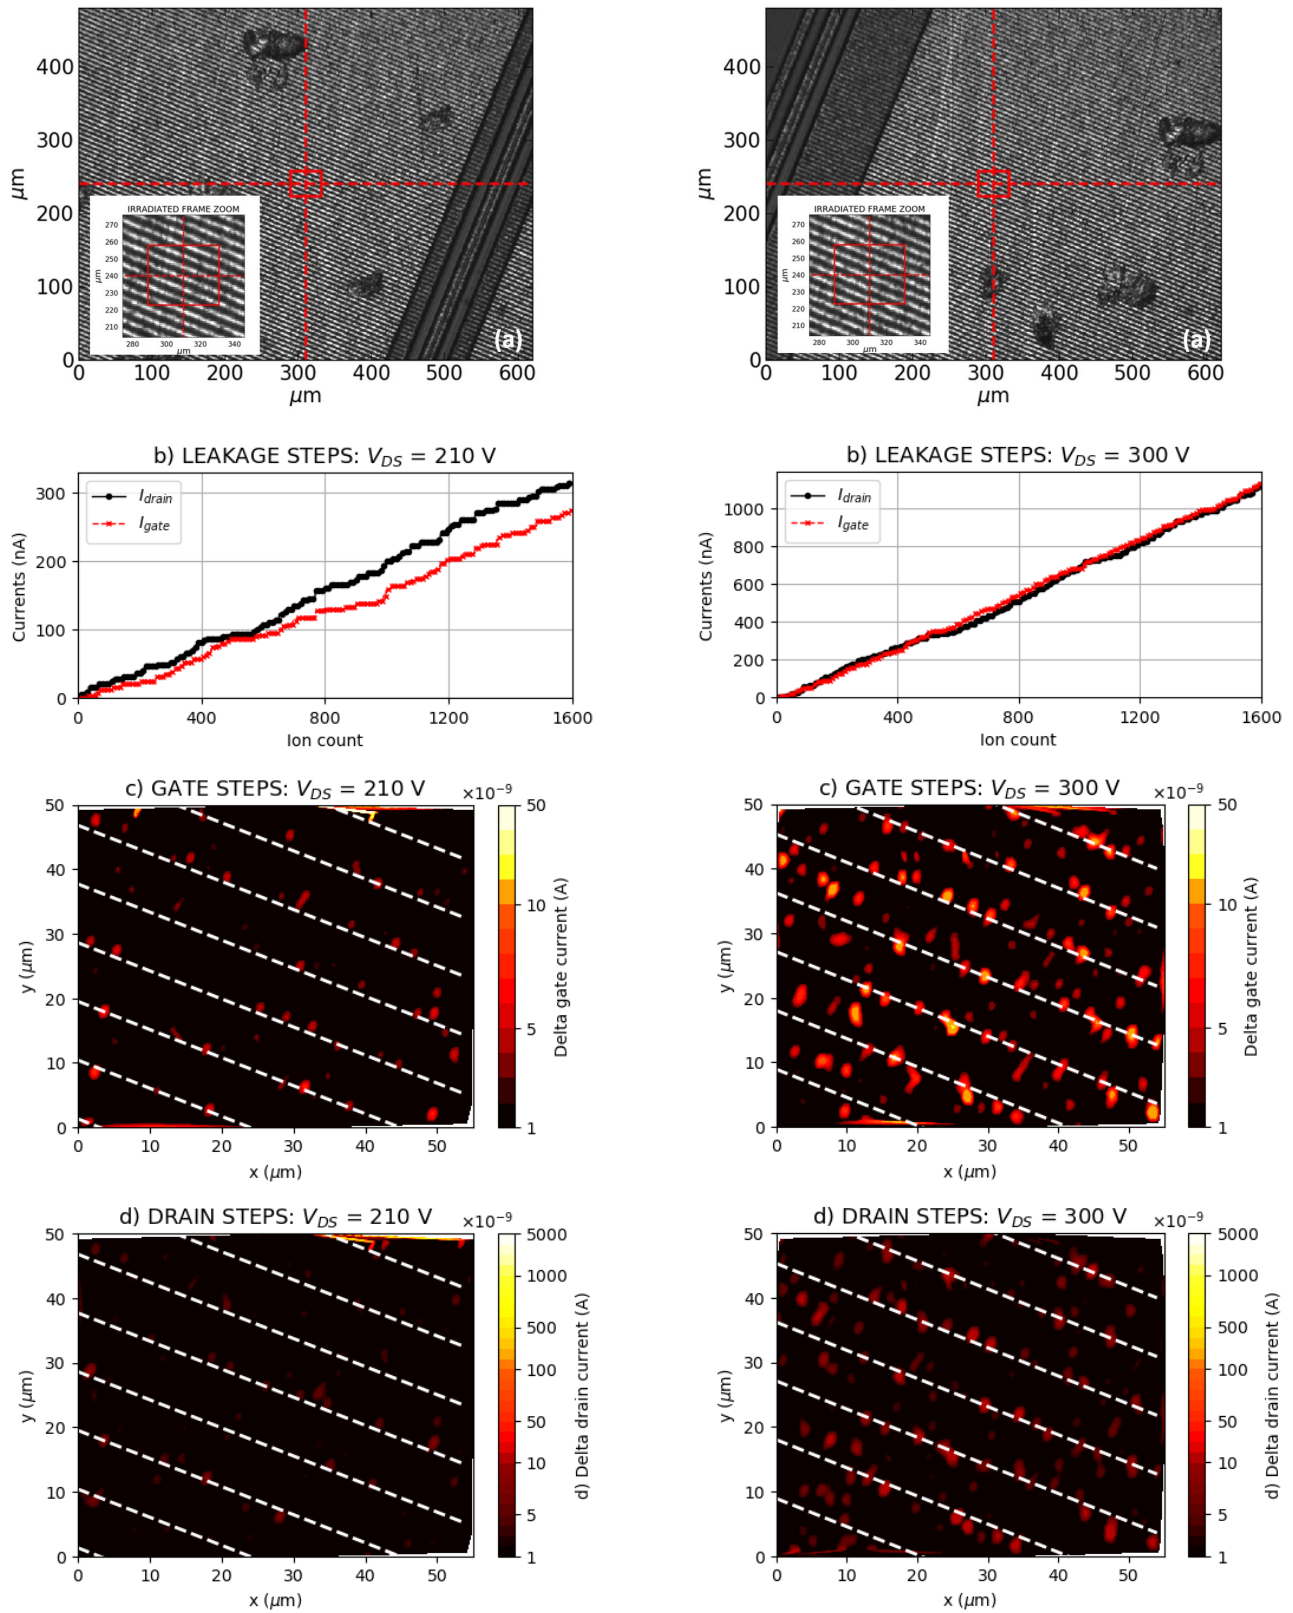
Fig. 3. All the runs refer to region 2 of an 80-m Ω DUT. (Left) $V_{DS\ irr} = 210\text{ V}$. (Right) $V_{DS\ irr} = 300\text{ V}$. From the top—(a) Frame selected for the irradiation in region 2 is visible on top of the microscope image; (b) drain and gate leakage current evolution during the irradiation; (c) and (d) the gate and the drain current steps are, respectively, represented as a function of the scanner position. The gate stripes were plotted within a distance of 9.1 μm , based on the technological information in (c) and (d) and they are comparable with the stripes in the zoom visible in (a).

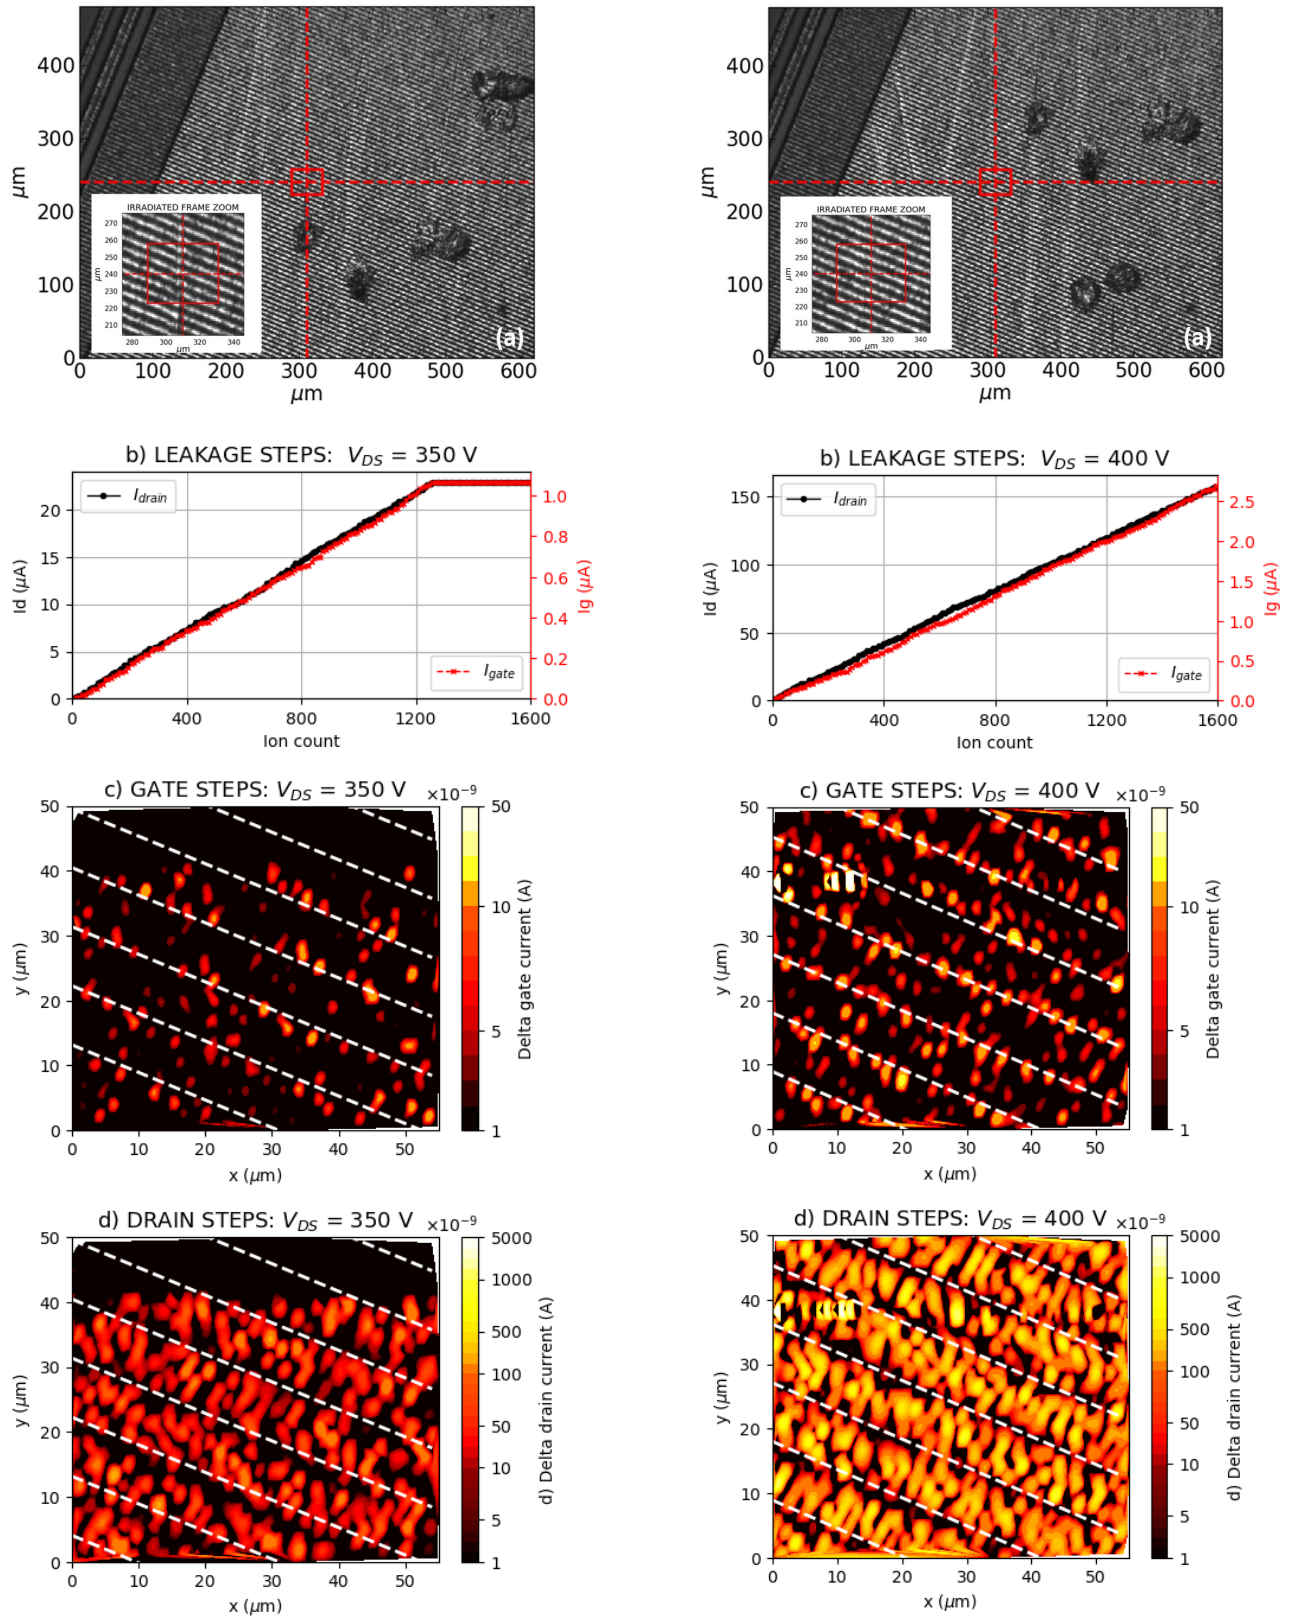
Fig. 4. All the runs refer to region 2 of an 80-m Ω DUT. (Left) $V_{DS\ irr} = 350\text{ V}$. (Right) $V_{DS\ irr} = 400\text{ V}$. From the top—(a) Frame selected for the irradiation in region 2 is visible on top of the microscope image; (b) drain and gate leakage current evolutions during the irradiation; (c) and (d) the gate and the drain current steps are, respectively, represented as a function of the scanner position. The gate stripes were plotted within a distance of 9.1 μm , based on the technological information in (c) and (d) and they are comparable with the stripes in the zoom visible in (a).

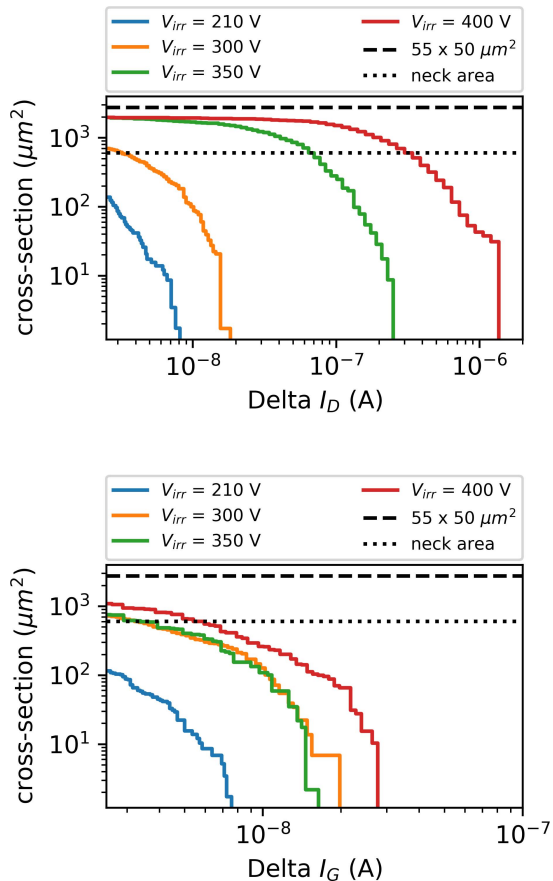
Fig. 5. CCDF for the measured cross section of the gate and drain SELC at different drain–source bias during the irradiation. For reference, the size of the exposure window and the estimated transistor’s neck area (or the JFET region) are illustrated in the graphs.

The cross sections for SELC probabilities in different biasing conditions can be represented using complementary cumulative distribution functions (CCDFs) for the measured gate and drain steps. The CCDFs for the four $V_{DS\ irr}$ conditions discussed earlier are shown in Fig. 5. Each bin represents the probability of the heavy-ion-induced step with a height above a given x -axis value. The distribution was normalized with the total number of ions in the run and the bin width. The probability to measure higher degradation steps increases with increasing drain-source bias during the exposure, as expected. Indeed, at $V_{DS\ irr} = 400$ V, the maximum step height for drain and gate currents was $\Delta I_D = 1.5 \times 10^{-6}$ A and $\Delta I_G = 2.9 \times 10^{-8}$ A, respectively. The size of the exposure window and the estimated transistor's neck region (within this window) are illustrated in the graphs. For the gate leakage, the probability saturates to values close to the neck area (or JFET region). Probably, the most sensitive areas for gate degradation are those close to the channel, but the resolution is not high enough to explicitly see that ($\Delta X = 1.1$ μm).

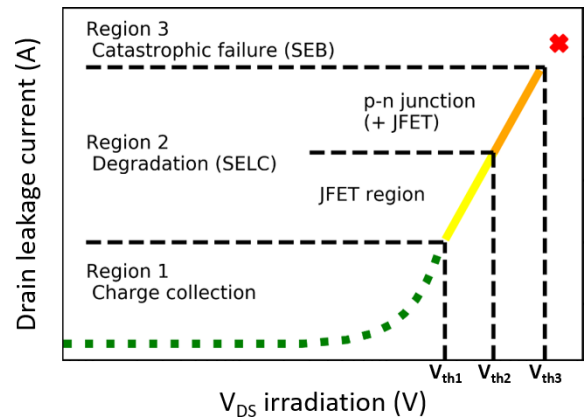
Fig. 6. Three characteristic regions of damage for SiC power MOSFETs as a function of the drain–source bias during the heavy-ion irradiation. Two subregions are identified for degradation (region 2). First, between V_{th1} and V_{th2} , the area underneath the gate (JFET or neck region) is the most sensitive for SELC. The second mechanism is newly added at biases higher than V_{th2} , when higher SELC is measured in the p-n junction area, but a smaller leakage remains also through the gate-oxide.

The microbeam results confirm that two different mechanisms are governing the SELC, involving different areas of the MOSFET structure. One mechanism is attributed to oxide damage (above the JFET or neck region) that results in the leakage path between the drain and the gate. The other degradation mechanism is triggered when the bias applied during the exposure is sufficiently high to reach certain electrical conditions within the p-n junction. These different areas for ion-induced drain leakage response are illustrated in Fig. 6, where the three regions discussed in [9] are updated with the new considerations. At low bias voltages, the ion-induced charge is collected with a similar multiplication mechanism as in Si MOSFETs and no permanent damage is observed in the device. At higher bias, two subregions are identified for degradation. First, between V_{th1} and V_{th2} , the area underneath the gate (the JFET area) is the most sensitive for SELC. More precisely, the channel area should also be included in this consideration. The second mechanism is observed at biases higher than V_{th2} , when higher SELC is measured in the p-n junction region, but a smaller leakage remains also through the gate-oxide. In the third region, at sufficiently high bias above V_{th3} , a catastrophic single-event burnout failure occurs.
