Title: Heavy-Ion Microbeam Studies of Single-Event Leakage Current Mechanism in SiC VD-MOSFETs

Heavy-Ion Microbeam Studies of Single-Event Leakage Current Mechanism in SiC VD-MOSFETs

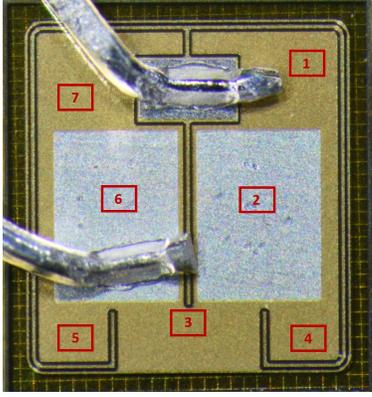
Fig. 1. Regions of the 80-mΩ die irradiated with Au beam (not to scale).

considerations are valid also for the 25- and 65-mΩ DUTs. For an exemplary 80-mΩ DUT, the irradiated regions are indicated in Fig. 1 (not to scale). During Au irradiation, gradual permanent degradation (SELC) in the device was observed at $V_{DS\ irr} > 150$ V ($\sim 12.5\%$ of the rated voltage). At drain biases below 350 V ($\sim 30\%$ of the rated voltage), the magnitude and degradation rate of the leakage currents, for both drain and gate, were equal. Similarly, it was observed for the 25-mΩ devices, while for the 65-mΩ devices from the third generation, equal gate and drain current were observed at $V_{DS\ irr} < 320$ V ($\sim 35\%$ rated voltage).

Different regions of the die were exposed to heavy ions, and detailed analyses were done for the second-generation 80-m Ω devices. The response to heavy ions was observed to be homogenous over the scanned areas around the die (as shown in Fig. 1).

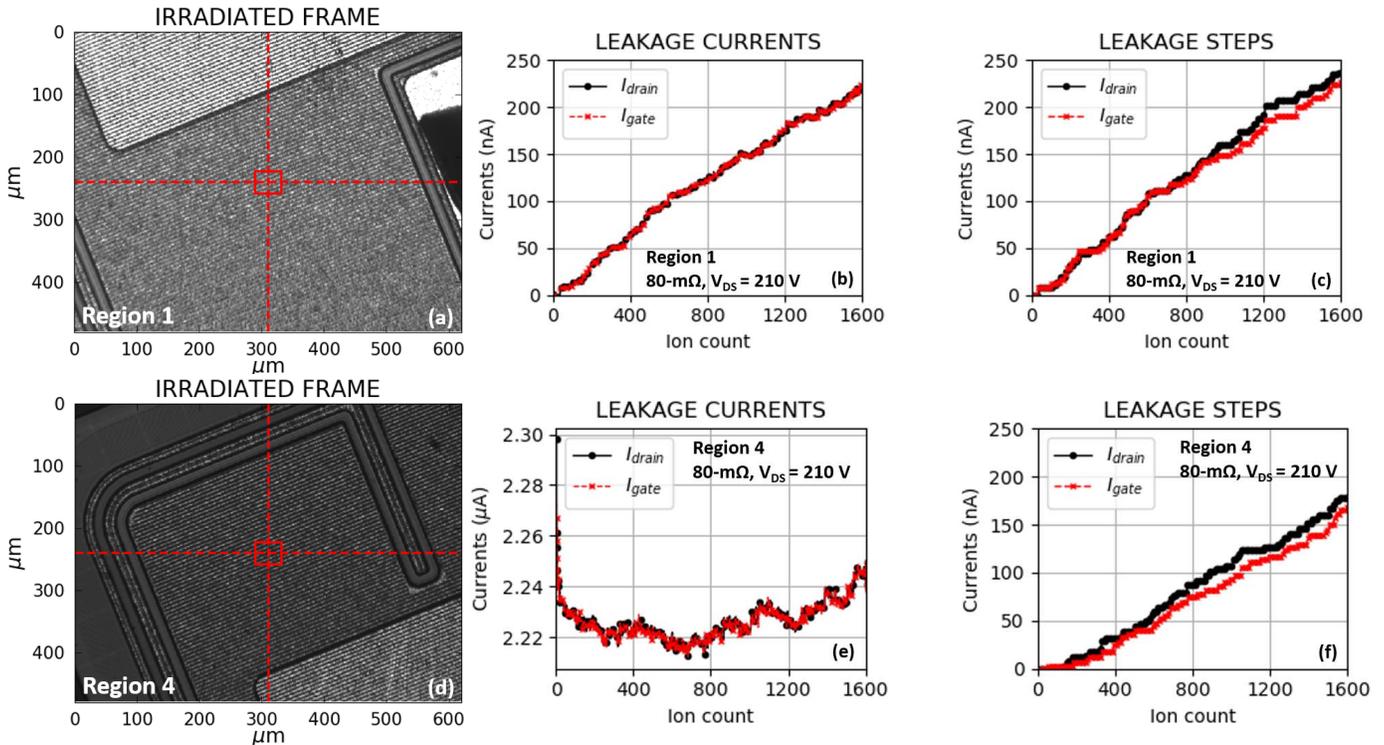
Fig. 2. Au irradiation in regions 1 and 4 of an 80-m Ω at $V_{DS\ irr} = 210$ V. The exact location of the irradiation is identified by the window frame on the microscope images, respectively, in (a) and (d). The drain and gate leakage current increases are shown in (b) and (e) (for a pristine device, the leakage currents are on the order of 10 pA), while in (c) and (f) is the cumulative sum of the radiation-induced leakage steps.

Two examples for an 80-mΩ die exposed to Au beam in regions 1 and 4 at $V_{DS\ irr} = 210$ V are shown in Fig. 2. The corresponding positions of the scanning areas are visible on the micrographs in Fig. 2(a) and (d). The leakage current evolution during the irradiations is shown in Fig. 2(b) and (e). The heavy-ion-induced steps were analyzed from the leakage current evolution by using a threshold step height of 2.5 nA to filter the background noise and are reported in Fig. 2(c) and (f).

had been degraded to a certain level. In the run shown in Fig. 2(b), the device exposed to the beam was pristine, while

in the run shown in Fig. 2(e), the part was already damaged. In the latter case, the leakage current was on the order

of microamperes. Comparing the current evolutions, for the degraded part [Fig. 2(e)], higher current values are measured

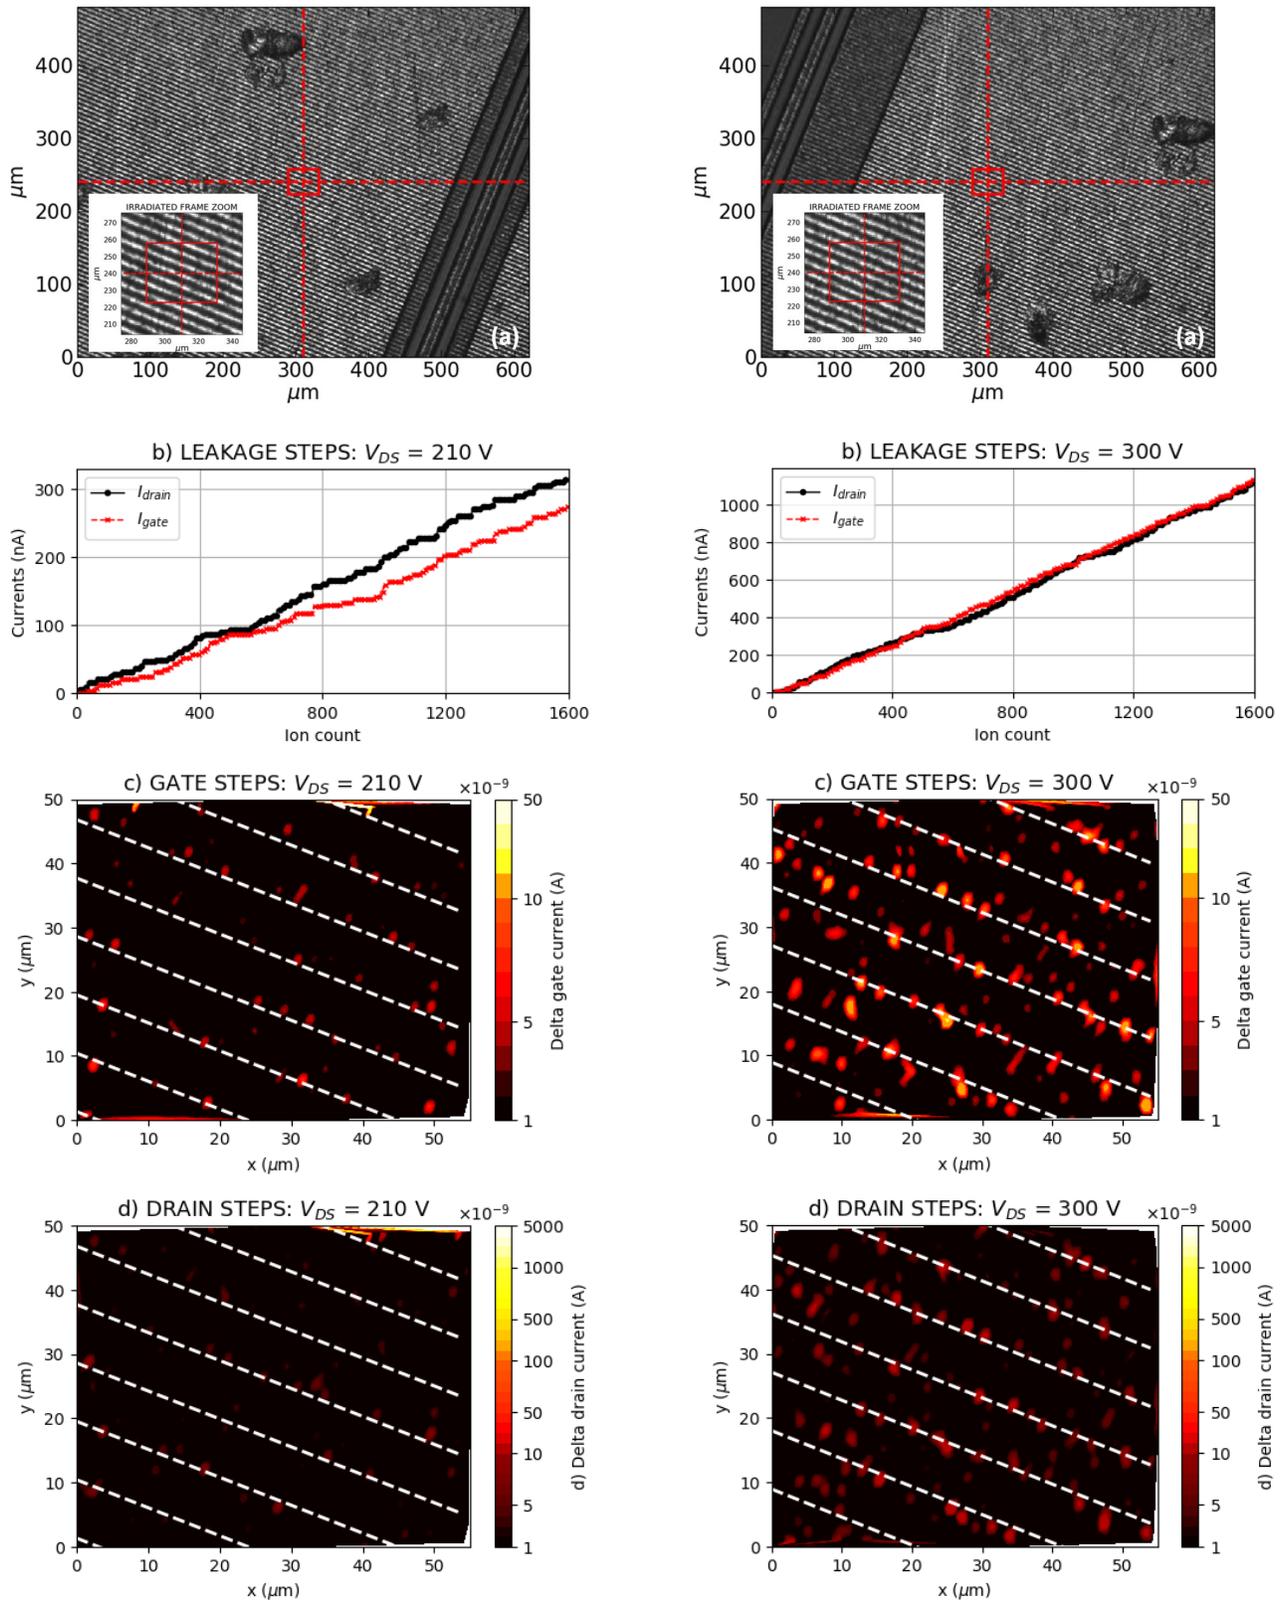
Fig. 3. All the runs refer to region 2 of an 80-m Ω DUT. (Left) $V_{DS\ irr} = 210\text{ V}$. (Right) $V_{DS\ irr} = 300\text{ V}$. From the top—(a) Frame selected for the irradiation in region 2 is visible on top of the microscope image; (b) drain and gate leakage current evolution during the irradiation; (c) and (d) the gate and the drain current steps are, respectively, represented as a function of the scanner position. The gate stripes were plotted within a distance of 9.1 μm , based on the technological information in (c) and (d) and they are comparable with the stripes in the zoom visible in (a).

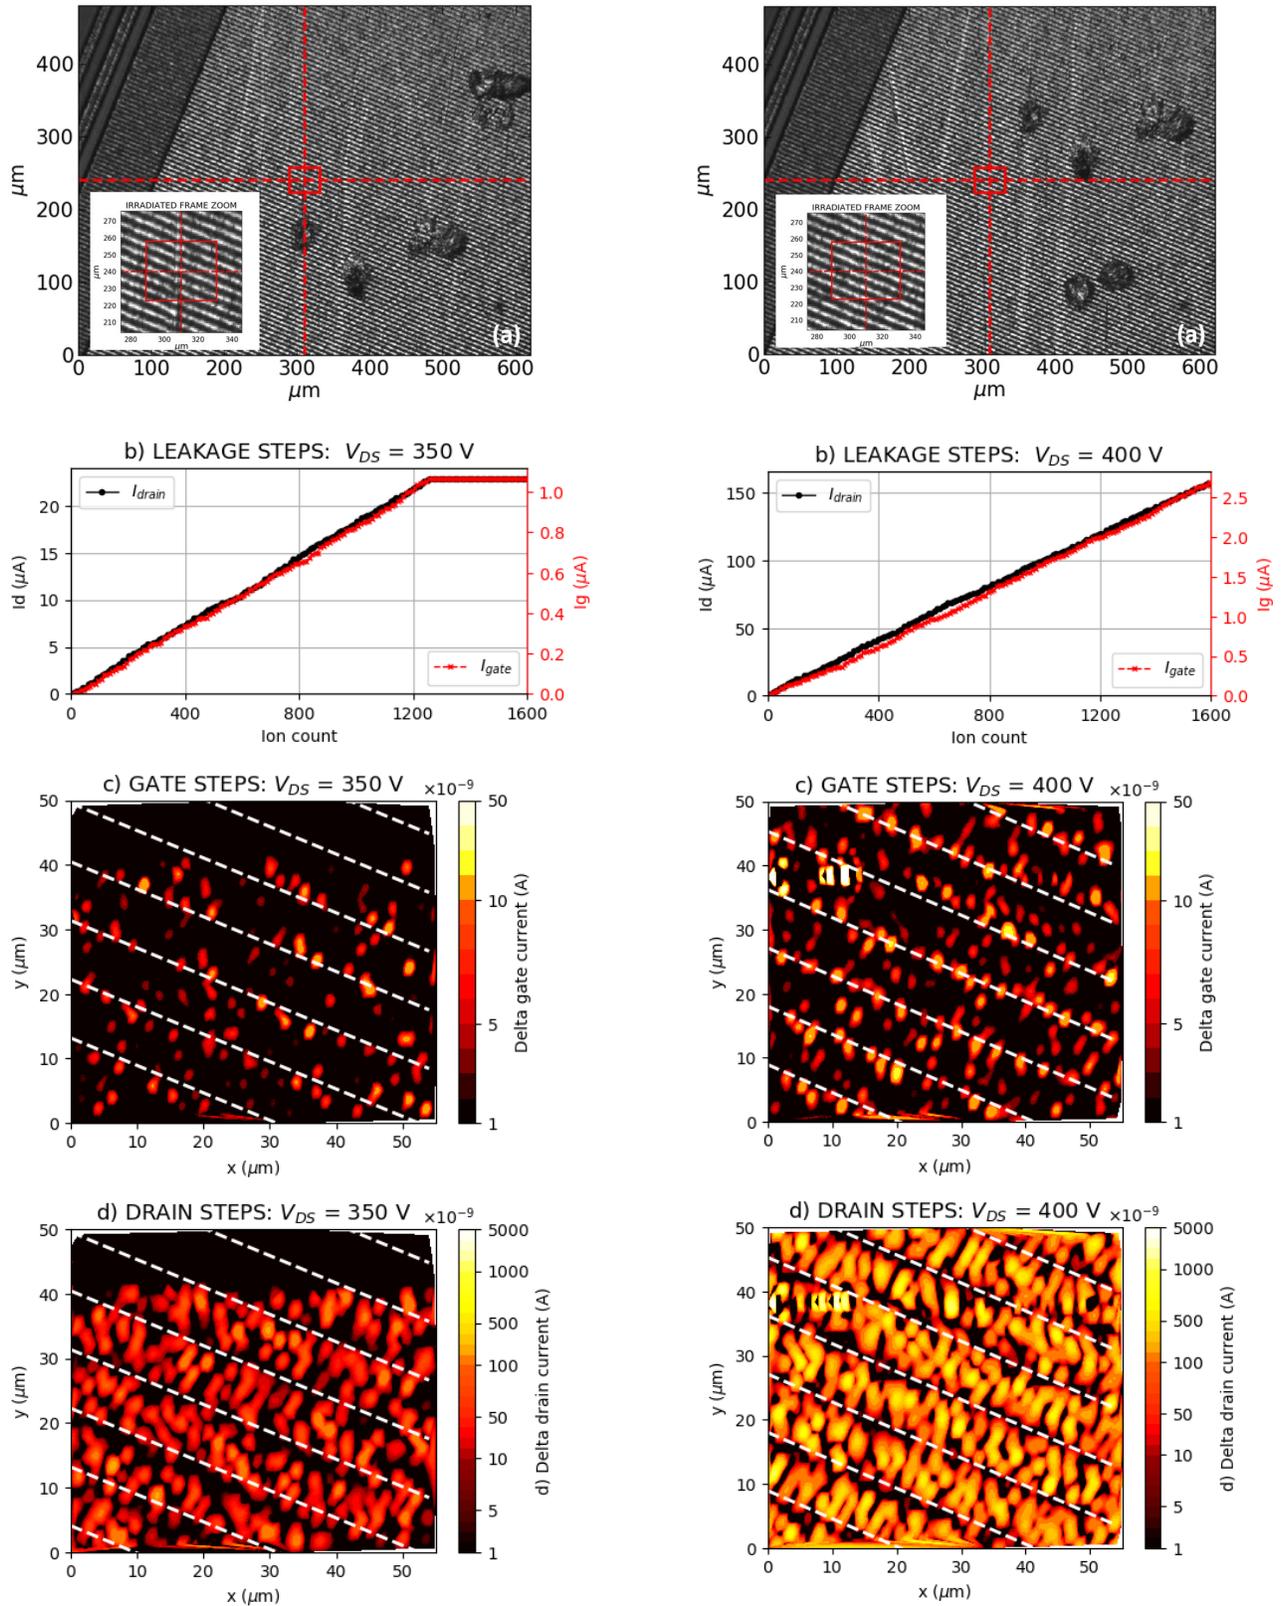
Fig. 4. All the runs refer to region 2 of an 80-m Ω DUT. (Left) $V_{DS\ irr} = 350\text{ V}$. (Right) $V_{DS\ irr} = 400\text{ V}$. From the top—(a) Frame selected for the irradiation in region 2 is visible on top of the microscope image; (b) drain and gate leakage current evolutions during the irradiation; (c) and (d) the gate and the drain current steps are, respectively, represented as a function of the scanner position. The gate stripes were plotted within a distance of 9.1 μm , based on the technological information in (c) and (d) and they are comparable with the stripes in the zoom visible in (a).

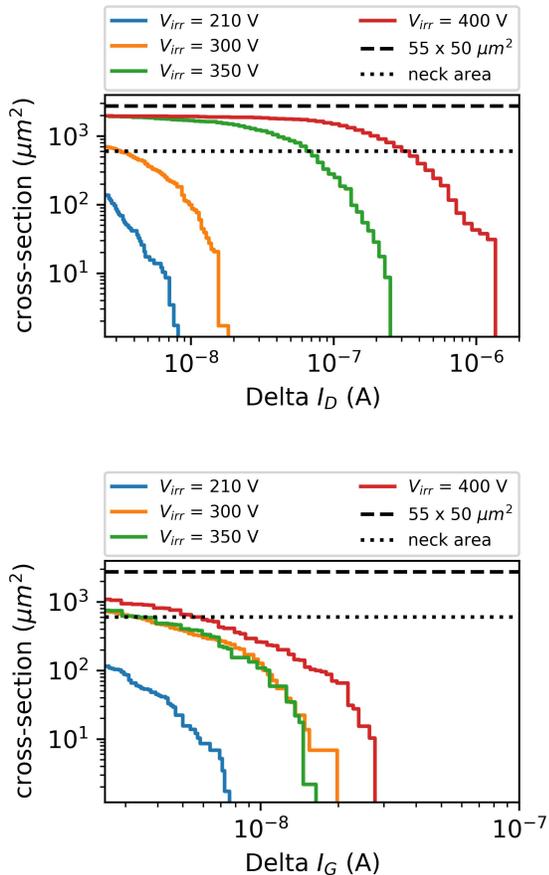
Fig. 5. CCDF for the measured cross section of the gate and drain SELC at different drain–source bias during the irradiation. For reference, the size of the exposure window and the estimated transistor’s neck area (or the JFET region) are illustrated in the graphs.

The cross sections for SELC probabilities in different biasing conditions can be represented using complementary cumulative distribution functions (CCDFs) for the measured gate and drain steps. The CCDFs for the four $V_{DS\ irr}$ conditions discussed earlier are shown in Fig. 5. Each bin represents the probability of the heavy-ion-induced step with a height above a given x -axis value. The distribution was normalized with the total number of ions in the run and the bin width. The probability to measure higher degradation steps increases with increasing drain-source bias during the exposure, as expected. Indeed, at $V_{DS\ irr} = 400$ V, the maximum step height for drain and gate currents was $\Delta I_D = 1.5 \times 10^{-6}$ A and $\Delta I_G = 2.9 \times 10^{-8}$ A, respectively. The size of the exposure window and the estimated transistor's neck region (within this window) are illustrated in the graphs. For the gate leakage, the probability saturates to values close to the neck area (or JFET region). Probably, the most sensitive areas for gate degradation are those close to the channel, but the resolution is not high enough to explicitly see that ($\Delta X = 1.1$ μm).

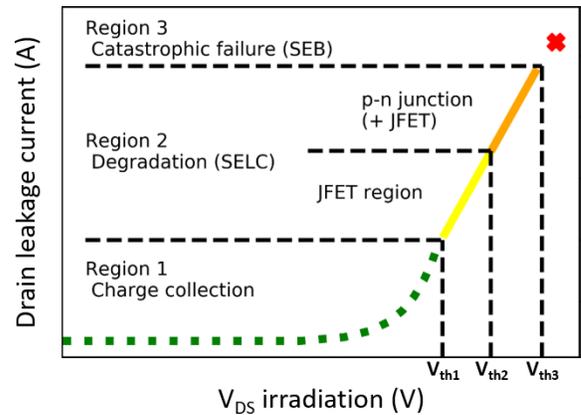
Fig. 6. Three characteristic regions of damage for SiC power MOSFETs as a function of the drain–source bias during the heavy-ion irradiation. Two subregions are identified for degradation (region 2). First, between V_{th1} and V_{th2} , the area underneath the gate (JFET or neck region) is the most sensitive for SELC. The second mechanism is newly added at biases higher than V_{th2} , when higher SELC is measured in the p-n junction area, but a smaller leakage remains also through the gate-oxide.

The microbeam results confirm that two different mechanisms are governing the SELC, involving different areas of the MOSFET structure. One mechanism is attributed to oxide damage (above the JFET or neck region) that results in the leakage path between the drain and the gate. The other degradation mechanism is triggered when the bias applied during the exposure is sufficiently high to reach certain electrical conditions within the p-n junction. These different areas for ion-induced drain leakage response are illustrated in Fig. 6, where the three regions discussed in [9] are updated with the new considerations. At low bias voltages, the ion-induced charge is collected with a similar multiplication mechanism as in Si MOSFETs and no permanent damage is observed in the device. At higher bias, two subregions are identified for degradation. First, between V_{th1} and V_{th2} , the area underneath the gate (the JFET area) is the most sensitive for SELC. More precisely, the channel area should also be included in this consideration. The second mechanism is observed at biases higher than V_{th2} , when higher SELC is measured in the p-n junction region, but a smaller leakage remains also through the gate-oxide. In the third region, at sufficiently high bias above V_{th3} , a catastrophic single-event burnout failure occurs.
