Title: Heavy-ion induced single event effects and latent damages in SiC power MOSFETs

Heavy-ion induced single event effects and latent damages in SiC power MOSFETs[☆]

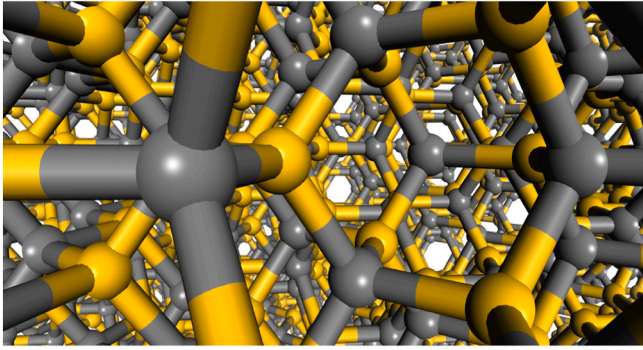
Fig. 1. Three-dimensional perspective of a 4H-SiC crystal in a ball-stick model. Yellow and gray circles represent respectively carbon (C) and silicon (Si) atoms. (For interpretation of the references to color in this figure legend, the reader is referred to the web version of this article.)

The wide-bandgap silicon carbide (SiC) semiconductor has emerged as the most viable alternative to silicon (Si) for the next-generation material for high-efficiency and high-power density applications [1,2]. Compared to Si, SiC exhibits an order of magnitude higher critical field for breakdown, three times larger bandgap, and three times higher thermal conductivity, resulting in about three times more efficient cooling capability [1]. The higher critical field allows manufacturing SiC power devices with much thinner drift layer compared to Si devices, reducing the resistance per unit area, and therefore reducing the conduction losses. Due to the wide bandgap, the intrinsic carrier density at room temperature (i.e., the electrons and holes generated by thermal excitation), is extremely low, enabling the SiC electronic devices to operate at high temperatures with low leakage current. These properties make SiC an attractive material to manufacture power devices by far exceeding the performance limits of their Si counterparts. A three-dimensional representation of the 4H-SiC polytype used to

manufacture power devices is shown in Fig. 1.

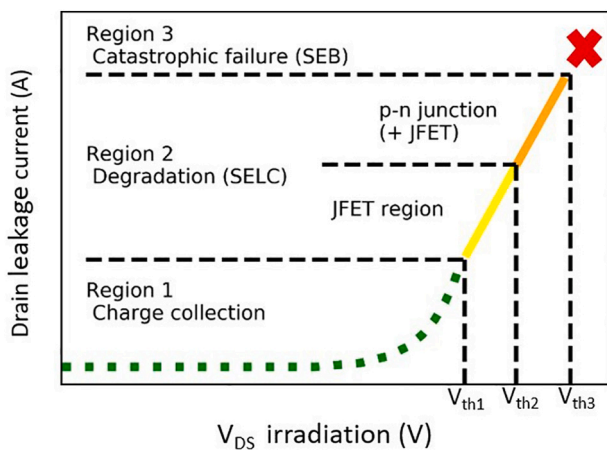
Fig. 2. Conceptual definition of three regions of response of a SiC MOSFET exposed to heavy-ions, represented with the drain-leakage current as a function of the drain-source bias during the irradiation.

Three regions of response are observed when monitoring the drain leakage current (I_D) of SiC power MOSFETs exposed to heavy-ions (a

planar-gate is considered). The three regions are represented in Fig. 2 as a function of the drain-source bias (V_{DS}). At low voltage, the ionization caused by the impinging particle induces only enhanced charge collection, with no permanent damage in the device (Region 1). Increasing the bias, degradation occurs, recently named Single Event Leakage Current (SEL) [10] (Region 2). This effect is characterized by a permanent increase in drain and gate leakage currents with increasing heavy ion fluence. Even though the SEL is non-destructive, the device operation is altered, and it complicates the assessment of radiation reliability for the tested parts. Two sub-regions were identified for this effect, as described in [10,11]. Initially, at a sufficiently high V_{DS} above V_{th1} , the drain and gate leakage currents increase with the same magnitude during the exposure, having a linear proportionality to the fluence. The conductive path is observed between the gate and drain terminals. The induced damage is permanent, and the leakage currents do not recover to the pristine values after the irradiation. From the ion microbeam studies, it was observed that the area underneath the gate (JFET and channel regions) is the most sensitive for this type of damage [10]. For V_{DS} higher than V_{th2} , the second mechanism of degradation becomes active; the gate current (I_G) keeps increasing linearly with respect to the fluence, whereas the drain current (I_D) starts increasing with a much larger magnitude respect to I_G . From the microbeam studies, the p-n junction was identified as the sensitive region at these voltage levels. This second mechanism of degradation was suggested to be the same as observed in SiC diodes, and to be caused by Joule heating, which results in increasing temperature and phase change in the SiC substrate, as confirmed by molecular dynamics simulations [23,24]. These affected regions are unlikely to recover completely, leaving permanent structural modification in SiC lattice, causing the creation of permanent extended defects (ED), such as different dislocations, amorphous pockets, stacking faults, different SiC solid-phase (polytype) inclusions, clusters, and so on [10]. Finally, at V_{DS} higher than V_{th3} , a destructive SEB occurs (Region 3).

The threshold voltages shown in Fig. 2, can vary with the manufacturer and the ion linear energy transfer (LET); a summary for the studied devices is presented in Section 4. In this case, the transition between the two types of degradation was always observed at $V_{th2} \geq 350$ V for LET > 10 MeV cm²/mg, as reported in [11].

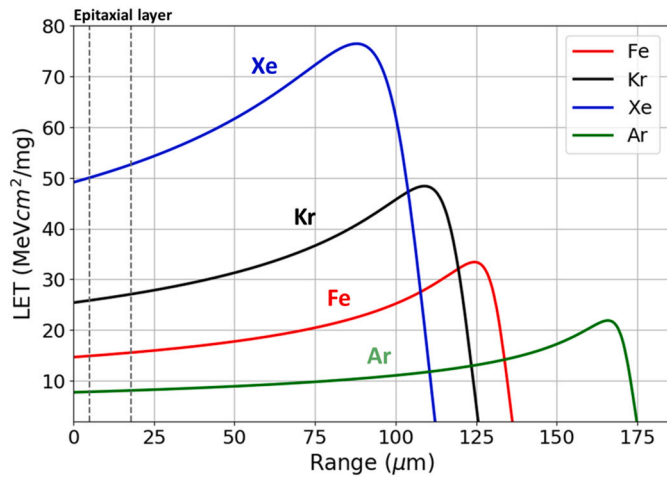
Fig. 3. LETs as a function of the penetration range for the 16.3 MeV/amu heavy-ion species used during the experiments. The dashed lines highlight the thickness of the epitaxial layer of the device.

(Finland). Two experiments were carried out in order to study the latent damage in the gate oxide and in the SiC crystal lattice. Ion broad beams from the 18 GHz Electron Cyclotron Resonance (ECR) ion source, HIISI [26], were used to irradiate commercial SiC MOSFETs. In both cases the irradiations were performed using the 16.3 MeV/amu heavy-ion cocktail, with ⁴⁰Ar⁺¹⁴, ⁵⁶Fe⁺¹⁵, ⁸²Kr⁺²² and ¹³¹Xe⁺³⁵ as the ion species selected for the test. The whole die was homogeneously exposed. The beam characteristics are reported in Table 1. The LET as a function of the penetration range for the four ion species is graphically represented in Fig. 3, where the thickness of the epitaxial layer of the devices is highlighted.

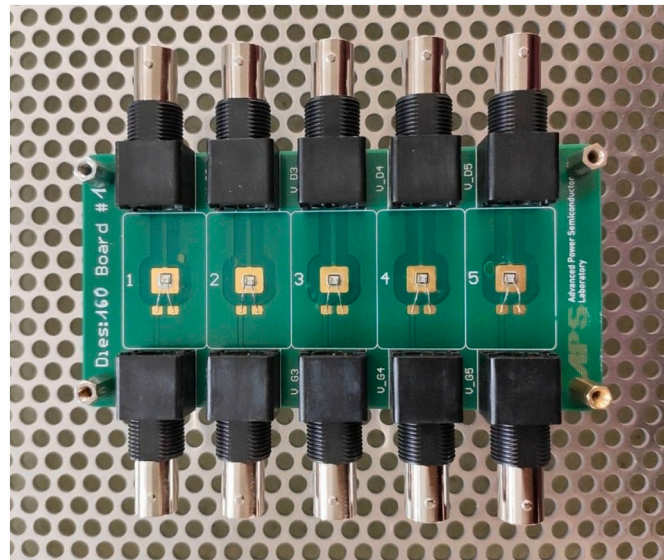
Fig. 4. Experimental board used at RADEF. Each board hosted five die, which were irradiated individually under vacuum. In the picture the die are from the 2nd generation Cree/Wolfspeed, rated for 1.2 kV and with $R_{DS(ON)} = 160$ mΩ. The BNC connectors allow to bias drain and gate and monitor the leakage currents (I_G and I_D).

Bare die from the 2nd generation of Cree/Wolfspeed, rated for $V_{DS} = 1.2$ kV were selected as devices under test (DUTs). Using bare die, the chip surface was directly exposed to the beam, allowing sufficient penetration of the heavy ions through the sensitive active layers of the device, without being stopped in the package materials [27]. The characteristics of the DUTs are listed in Table 2. The gate and source were connected by aluminum wire bonds with 300 μm wire diameter, while the drain connection was made by the soldered bottom pad. The source terminal was directly grounded on the board. Only two wires (gate and source) were used to minimize the shadowing effect. Each board hosted five die, which were irradiated individually in vacuum conditions. Two Keithley Source Measure Units (SMUs), models 2636 and 2410, were used to bias gate and drain through BNC connectors and monitor the gate and drain currents (I_G and I_D), respectively. A picture of the experimental board is shown in Fig. 4.

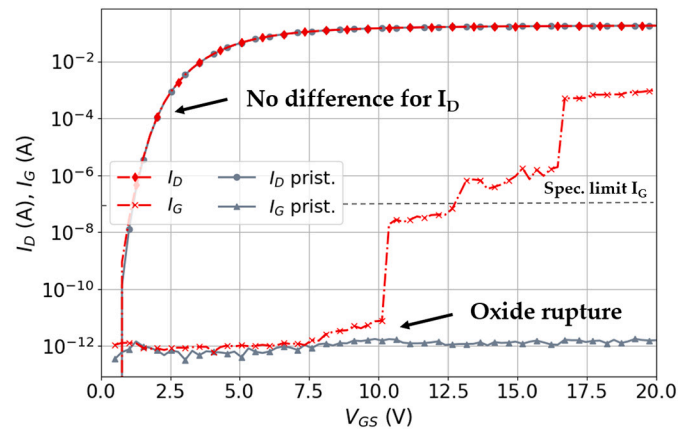
Fig. 5. $I_D V_{GS}$ and $I_G V_{GS}$ of a DUT exposed to ¹³¹Xe⁺³⁵ at $V_{DS} = 60$ V. No degradation was observed during exposure, but oxide breakdown occurred due to the latent damage during the PIGS test at $V_{GS} = 10$ V.

For each ion species, a range for the V_{DS} threshold was identified for the oxide latent damage, as reported in Table 3. The V_{DS} threshold is defined as the minimum bias at which no degradation is observed during the exposure, but the latent damage at the gate is sufficient to cause the oxide rupture during the PIGS test (i.e., $V_{GS} = [0 \text{ V} - 20 \text{ V}]$). For comparison, also the threshold voltages for degradation are reported. The latter were measured either during the current experiment, or during previous experiments with devices from the same generation [10,11]. The results from the run with $^{131}\text{Xe}^{+35}$ at $V_{DS} = 60 \text{ V}$ (and V_{GS} grounded) are shown as an example in Fig. 5. No degradation was observed during the exposure with a fluence up to $10^6 \text{ ions}/\text{cm}^2$, however the gate oxide failed at $V_{GS} = +10 \text{ V}$ during the PIGS test, showing a gate latent damage induced by the ion-exposure. From the application point of view, the device is considered not operable anymore, as $I_G > 100 \text{ nA}$, and therefore out of specifications.

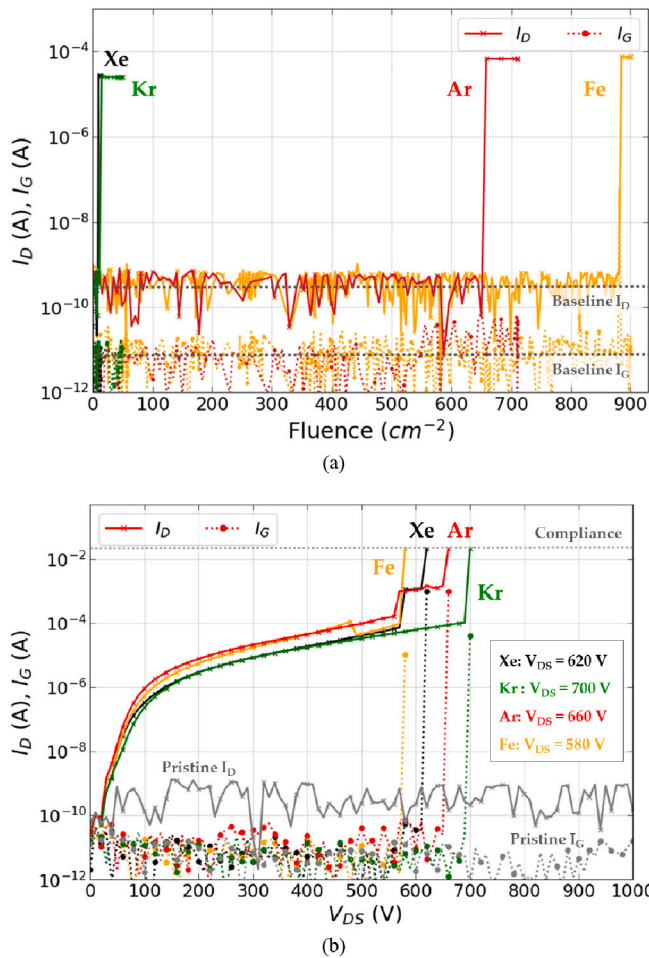
Fig. 6. Results from irradiations with $^{40}\text{Ar}^{+14}$, $^{56}\text{Fe}^{+15}$, $^{82}\text{Kr}^{+22}$ and $^{131}\text{Xe}^{+35}$ ions. a) First degradation step during the exposure at $V_{DS} = 450$ V. b) Post-irradiation V_{DS} sweep; all the devices failed at $580 \text{ V} < V_{DS} < 700$ V. The pristine I_D and I_G are shown in gray.

investigating the latent damage in the SiC crystal lattice in the pre-SEB region. Bare die with $R_{DS(ON)} = 40 \text{ m}\Omega$ (CPM2-1200-0040B) were irradiated at $V_{DS} = 450 \text{ V}$ in order to protect from SEB (for these parts approximately at $V_{DS} = 500 \text{ V}$ with $LET > 10 \text{ MeV cm}^2/\text{mg}$ [13]) and $V_{GS} = 0 \text{ V}$. A flux of few tens of ions/($\text{cm}^2 \text{ s}$) was used, and each die was exposed until the first radiation-induced step was observed. At this bias condition, the devices are experiencing the second type of degradation, which involves the p-n junction and the creation of EDs. The first degradation step was observed only in the I_D , which reached tens of μA , whereas the I_G remained in the order of magnitude of the pristine values. The I_D and I_G results are reported in Table 4 for four DUTs irradiated with $^{40}\text{Ar}^{+14}$, $^{56}\text{Fe}^{+15}$, $^{82}\text{Kr}^{+22}$ and $^{131}\text{Xe}^{+35}$. The same results are graphically represented in Fig. 6(a) as a function of the fluence during the exposure. The pristine values are reported for comparison in the same image (in gray). After the exposure, I_D and I_G were measured simultaneously using the same setup, having $V_{DS} = [0 \text{ V} - 1000 \text{ V}]$ and $V_{GS} = 0 \text{ V}$. As visible in Fig. 6(b), all four DUTs exposed at $V_{DS} = 450 \text{ V}$ failed during the post-irradiation V_{DS} sweep at voltage range of $580 \text{ V} < V_{DS} < 700 \text{ V}$. The failure was defined as $I_D = 20 \text{ mA}$, which is the level of the compliance. As visible in Table 4, in this case the failure

voltage does not show a clear trend with the ion LET. This is probably caused by the different ion-strike position in the unit cell of the MOSFET.

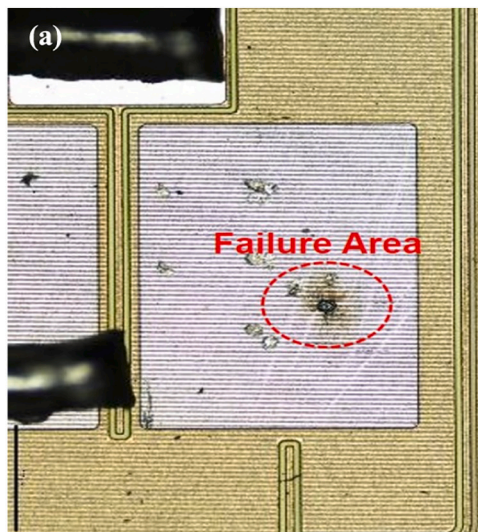
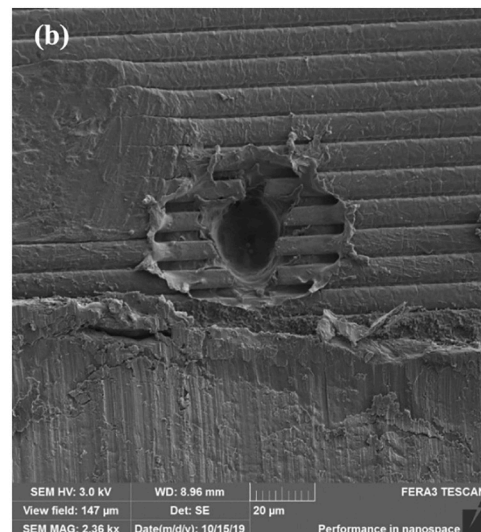
Fig. 7. Images of the failure are on the die surface obtained with (a) microscope and (b) SEM analysis measured with SE detector.

The damage site caused by the post-irradiation V_{DS} measurement was investigated using a plasma FIB-SEM analysis. The device analyzed was tested on a previous experiment performed with a microbeam as described in [10] but showed the same type of post-irradiation damage. The device was exposed to Ca ion ($LET = 17 \text{ MeV cm}^2/\text{mg}$) with an accumulated fluence of $6 \times 10^3 \text{ ions/cm}^2$. Initially, the failure area was identified using a microscope, as visible in Fig. 7(a). Fig. 7(b) shows a SEM image of the damage site on the die surface measured with SE detector. The hole generated by the failure extends over more than three gate stripes, for a length of $\sim 30 \mu\text{m}$ and a width of $\sim 20 \mu\text{m}$. Fig. 8(a) and Fig. 8(b) show the cross-section of the hole after FIB milling, measured with SE and BSE detector, respectively. The hole has a depth of $\sim 18 \mu\text{m}$, and it extends over the entire epilayer (which has a depth from $5 \mu\text{m}$ to $18 \mu\text{m}$). The image shows that the SiC crystal has decomposed, meaning that the localized temperature in the failure region reached the

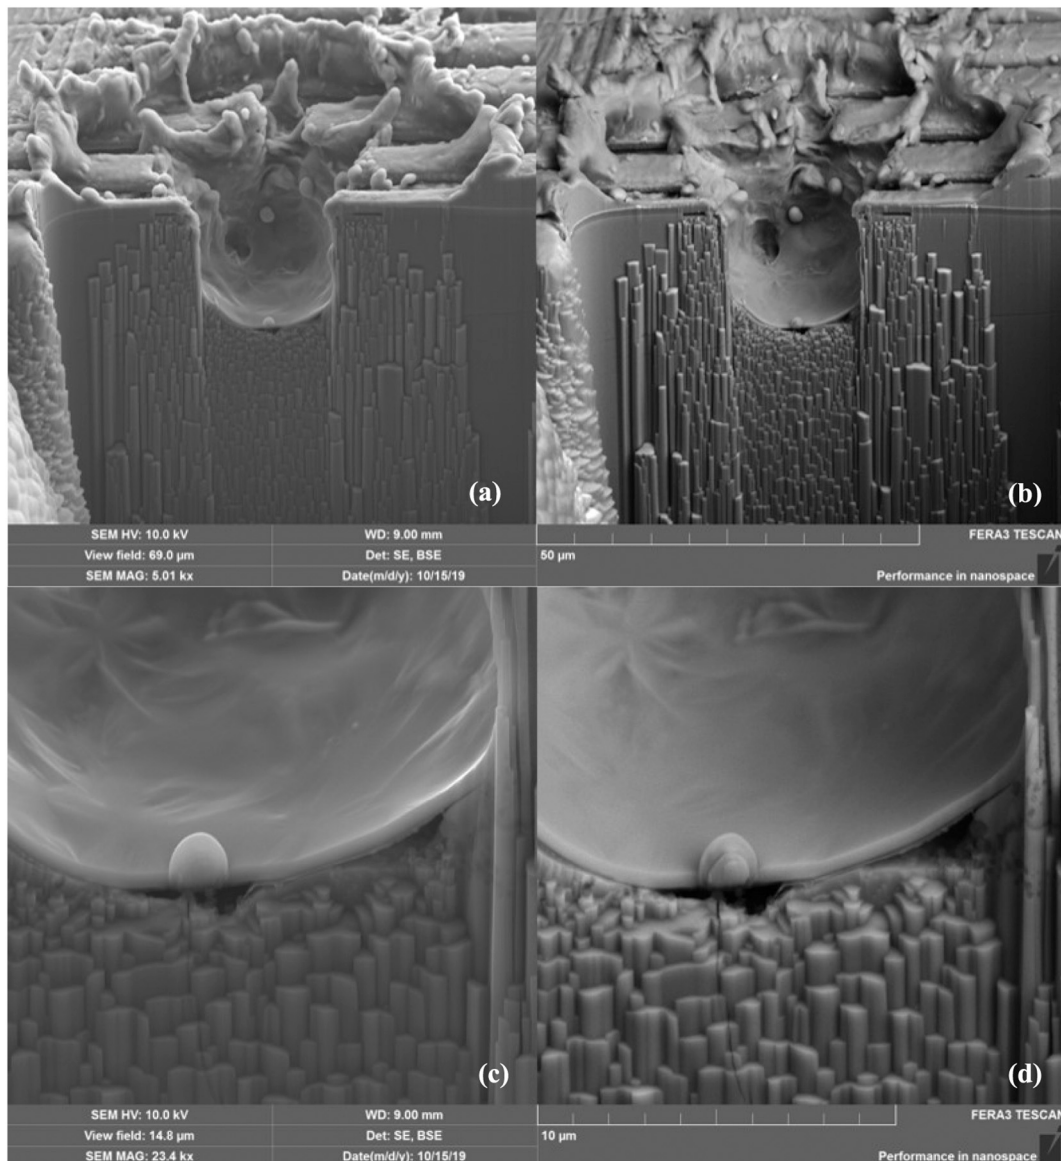
Fig. 8. In the top row: cross-section of the damaged area after FIB milling, measured with (a) SE and (b) BSE detectors. In the bottom row: magnified view of the hole showed in the previous images, measured with (c) SE and (d) BSE detectors.

decomposition temperature of 4H SiC ($3103\text{ K} \pm 35\text{ atm}$ [28]), and the materials in the layers above, which have a lower melting point, filled the hole. Fig. 8(c) and Fig. 8(d) are magnified views of the hole showed in the previous images, measured with SE and BSE detector, respectively. A crack which starts at the bottom of the hole is visible in both images. Finally, the vertical columns that appear in the cross-sections are artifacts due to the preparation of the sample.

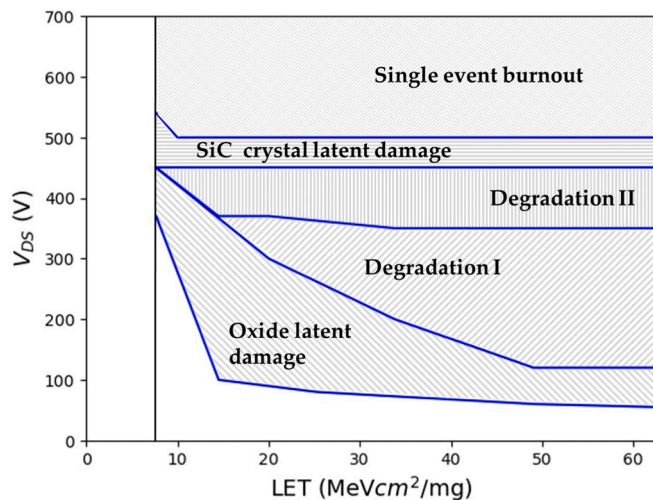
Fig. 9. Overview of the different types of damage induced by heavy-ion in SiC power MOSFETs as a function of the ion LET. The data were collected testing planar-gate MOSFETs from the 2nd generation Cree/Wolfspeed. The plot follows the representation as proposed in [10] for SiC diodes.

The heavy-ion-induced effects in the 2nd generation SiC MOSFET devices from Cree/Wolfspeed are graphically represented in Fig. 9 as a function of the ion LET and the V_{DS} during the exposure. The plot follows the representation as proposed in [17] for SiC diodes. The data were collected in the current work and previous ones [10,11] for devices irradiated in off-state. Five different regions of damage with the respective thresholds are identified.

A “hockey stick” trend is observed for all the effects, with the regions becoming narrower and the threshold voltages less distinguishable with decreasing LET. No data was collected for $LET < 7.7\text{ MeV cm}^2/\text{mg}$, but eventually the ion damage is insufficient to induce degradation and latent damage, and the device directly experience SEB at higher bias.

At low drain-source bias, the first type of effect observed is the gate latent damage discussed in Section 3.1. The V_{DS} necessary to observe this effect is extremely low compared to the maximum rated voltage (less than a tenth). The threshold for this effect was identified for a fluence of 10^6 ion/cm^2 . At higher bias, the heavy-ion exposure induces the first type of SELC, named “degradation I” in this graph, where the area underneath the gate oxide is the most sensitive (JFET region + channels). Increasing the voltage, the second type of SELC, labelled “degradation II”, is observed. In this case the damage involves mostly the p-n junction region, but a smaller leakage remains also through the gate-oxide. This type of degradation involves damage in the SiC lattice and generation of EDs. The transition between the two types of degradation might vary between device generations and manufacturers, as recently reported in literature [5]. Furthermore, over a certain V_{DS} threshold in the pre-SEB region ($V_{DS} \geq 450\text{ V}$ in this case), a second latent damage involves the SiC crystal lattice which is altered by the presence of EDs. After the irradiation, when drain-source bias is applied, the localized power density induces an increase of local temperature, which ultimately causes the decomposition of the SiC crystal and the creation of a crater, as described in Sections 3.2 and 3.3. Finally, for

higher voltages, the device experiences directly a destructive SEB, as reported in [13] for $V_{DS} > 500\text{ V}$ and $LETs > 10\text{ MeV cm}^2/\text{mg}$.

This graph can be used as a qualitative baseline also for other devices with a planar gate. However, since in this work all the heavy-ions experiments were performed using planar MOSFETs from Cree/Wolfspeed and considering that design and carrier concentrations vary between device types and manufacturers, the results cannot be transferred to all SiC power devices without further analysis.
